Quaker Run and Buck Run Watershed Assessment and Restoration Plan

Aaron S. Clauser, PhD, CPESC
Clauser Environmental, LLC
1915 Leiby Lane
Kutztown, PA 19530
aclauser@verizon.net

Shamokin Creek Restoration
Alliance
PO Box 263
Mt. Carmel, PA 17851
570-286-7114

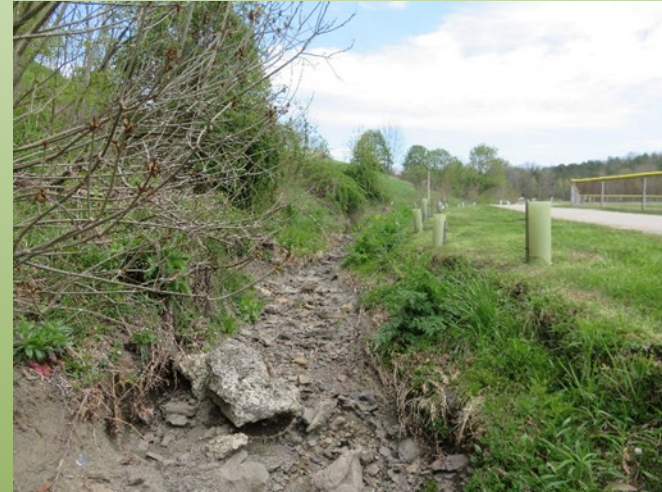
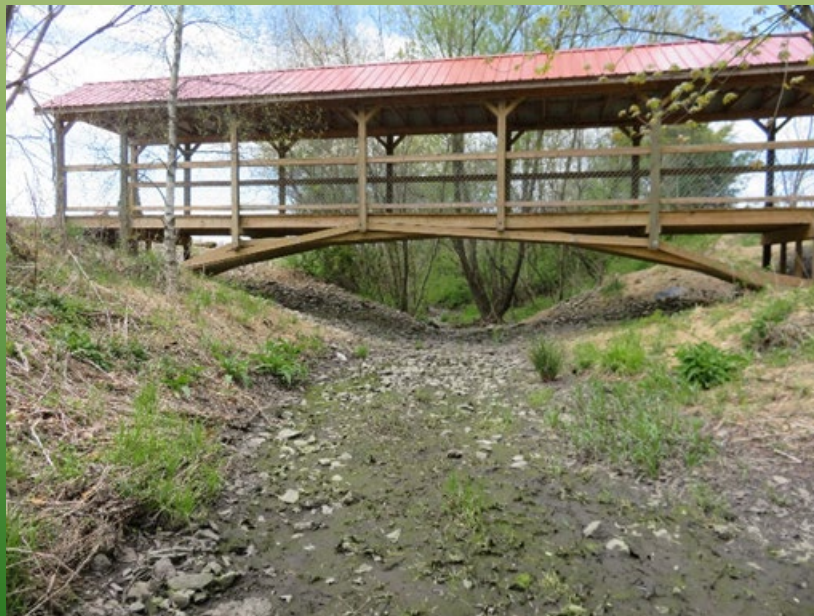
Impacted Stream Segment #11-18:

- Substantial infiltration of Quaker Run into underground mine pool
- Infiltration results in downstream areas being dry most days, despite upstream flow
- Eroding streambanks
- Trash and debris dumped upslope

- Restoration of existing channel
- Stormwater retrofits including a bioretention area
- Streambank stabilization
- Litter cleanup

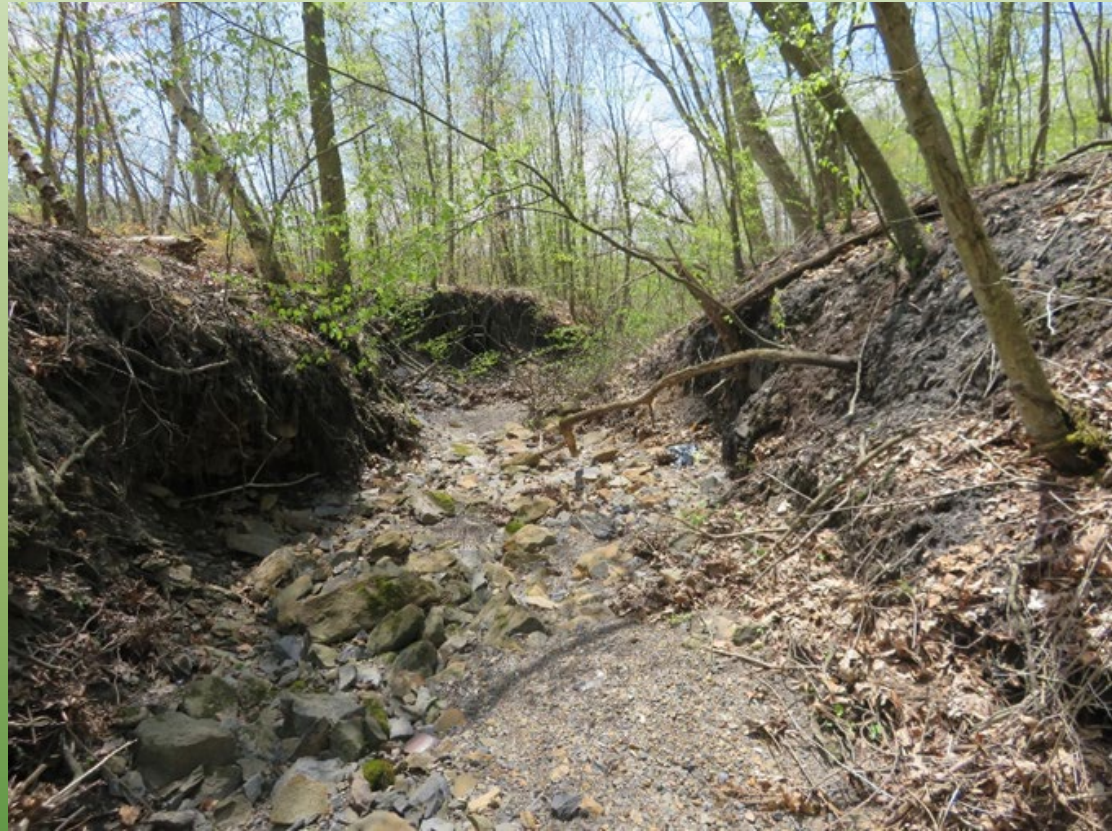
Impacted Stream Segment #22-23:

- Stream previously moved for mining operations
- Extreme erosion of 5-15' streambanks
- Erosion contributing to sediment pollution in stream channel

- Riparian zone restoration
- Connection to active floodplain
- Streambank stabilization

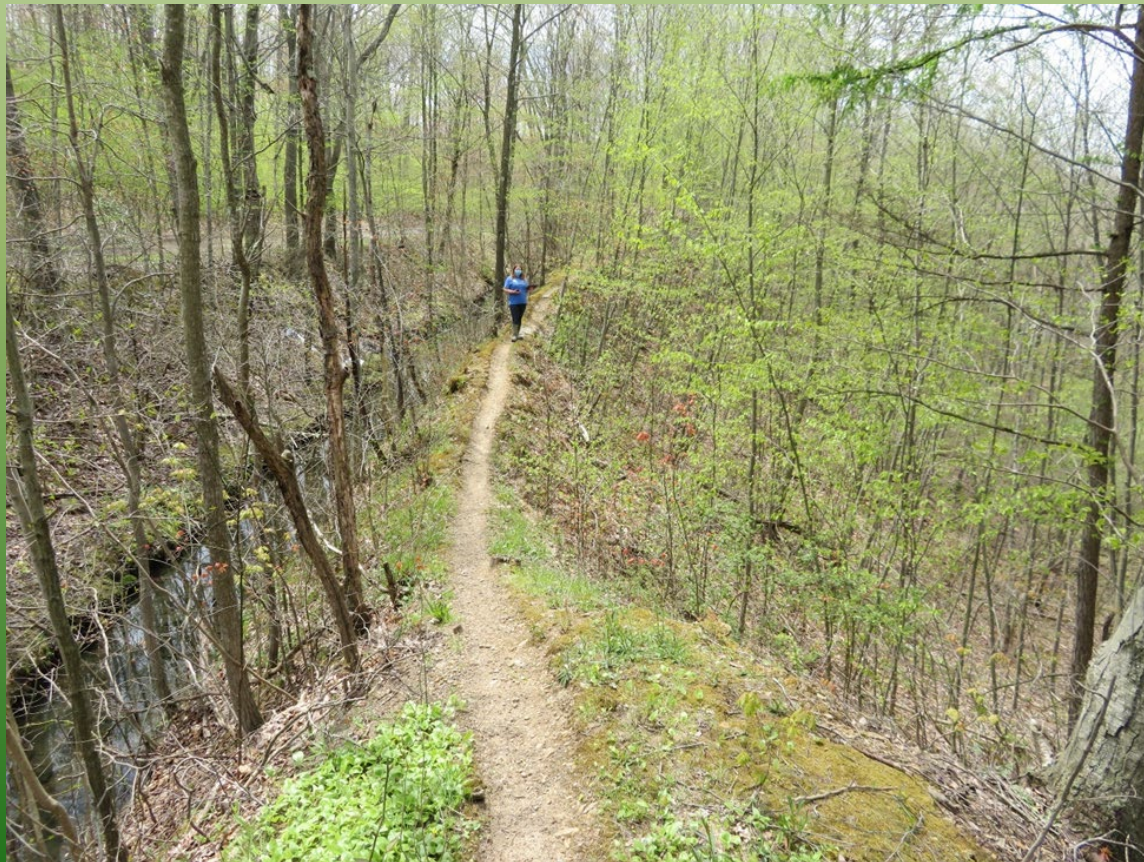
Impacted Stream Segment #26-27:

- No active floodplain
- Section of Quaker Run diverted south of strip mine pit

- Reclaim strip mine pit
- Streambank stabilization
- Restore an active floodplain to the area
- Install a clay liner in stream bed
- Plant native vegetation

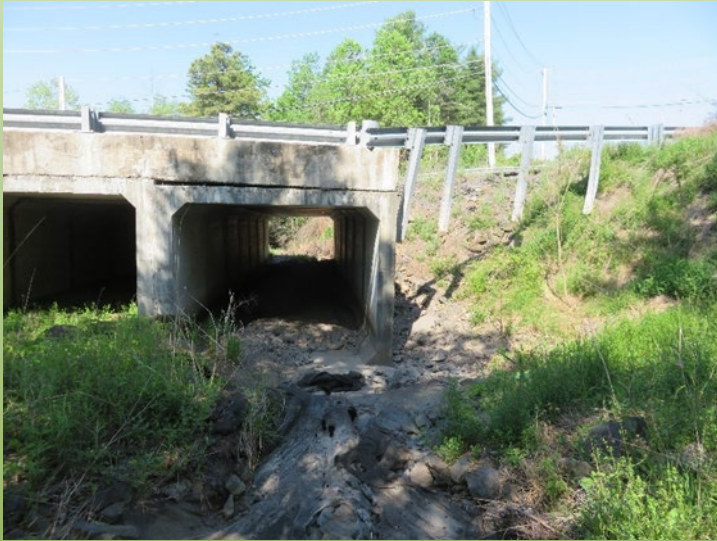
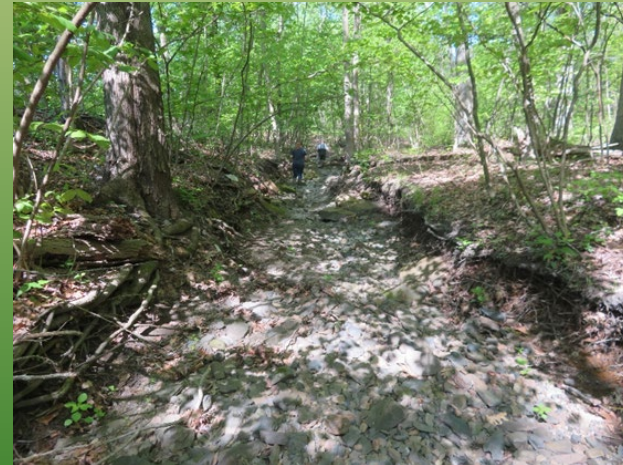
Impacted Stream Segments #33-39:

- Infiltration to an underground mine pool leaves the downstream portion of the channel dry
- Active erosion of 3-10' high stream banks
- Invasive plants dominate that floodplain

- Re-mining of the stream section and reclamation of the valley
- Elimination of underground mine workings
- Streambank stabilization
- Reconnection of floodplains
- Removal of invasive species and planting of natives

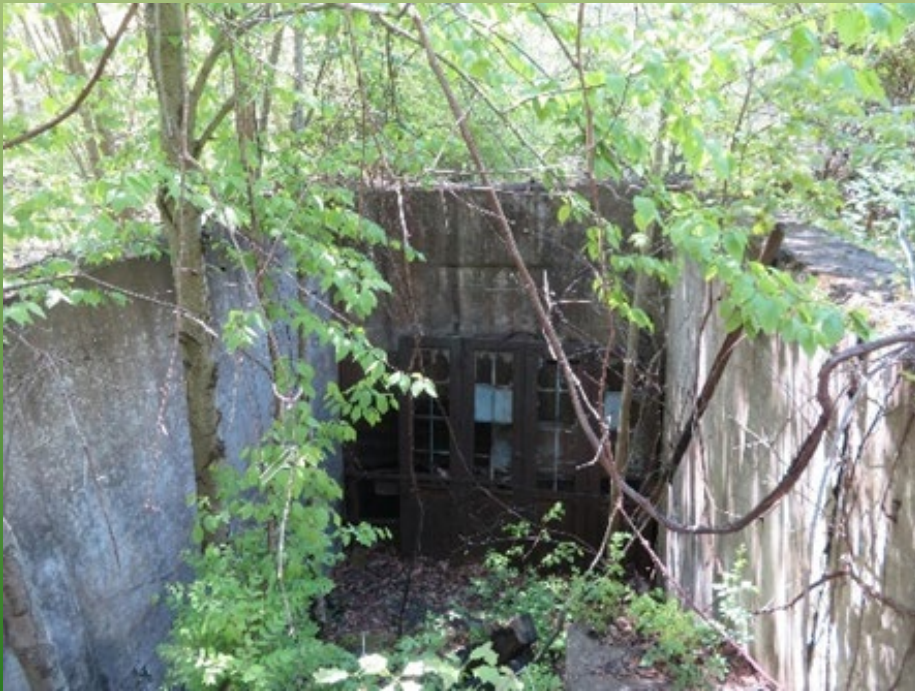
Impacted Stream Segments #46, 58:

- Mine drainage discharge contaminates stream channel
- Heavy contamination of metals
- pH of 6.18-6.45

- Reduce mine infiltration, removal of waste coal
- Elimination of underground mine operations
- Blocking the mine entrance with a cage that still allows for the passage of bats

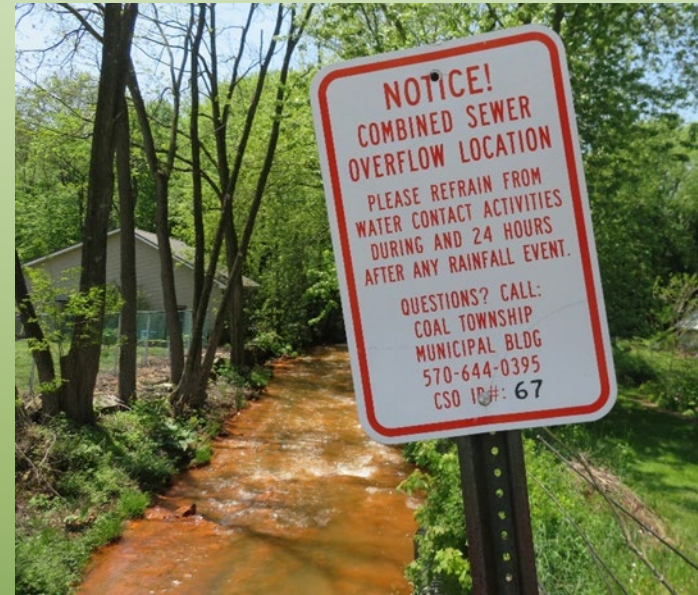
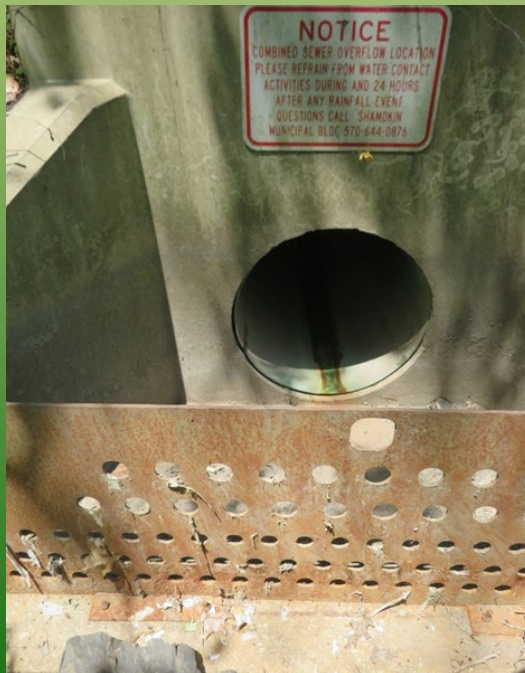
Impacted Stream Segments #62-64:

- Sewer overflow directly discharged into Quaker Run
- Only treatment of this sewage is bleach
- Quaker Run contaminated with feces, urine, grease, and harmful chemicals
- This puts downstream communities at risk

- Separation of stormwater discharges and sewer systems
- Local authorities already working on this separation

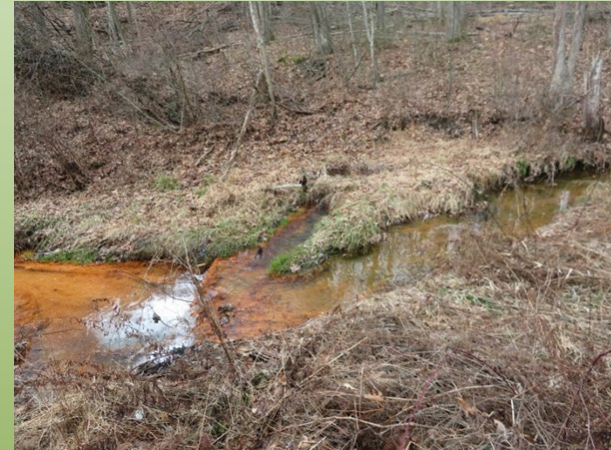
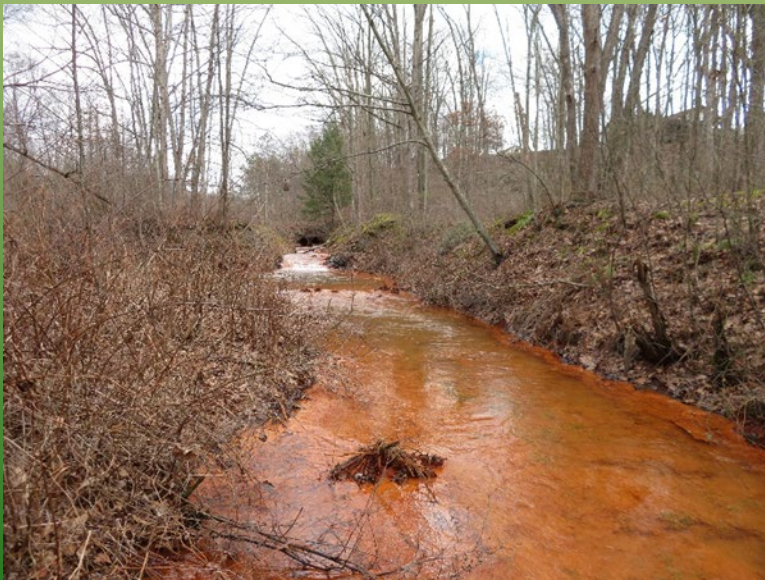
Impacted Stream Segments #85-87:

- Scott Ridge Mine Tunnel Discharge
- Discharge to Dark Run contaminated with mine drainage
- Heavy contamination of metals
- pH of 5.77

- Reclamation of above and below ground mine workings
- Limiting surface water drainage
- Treatment of mine discharge

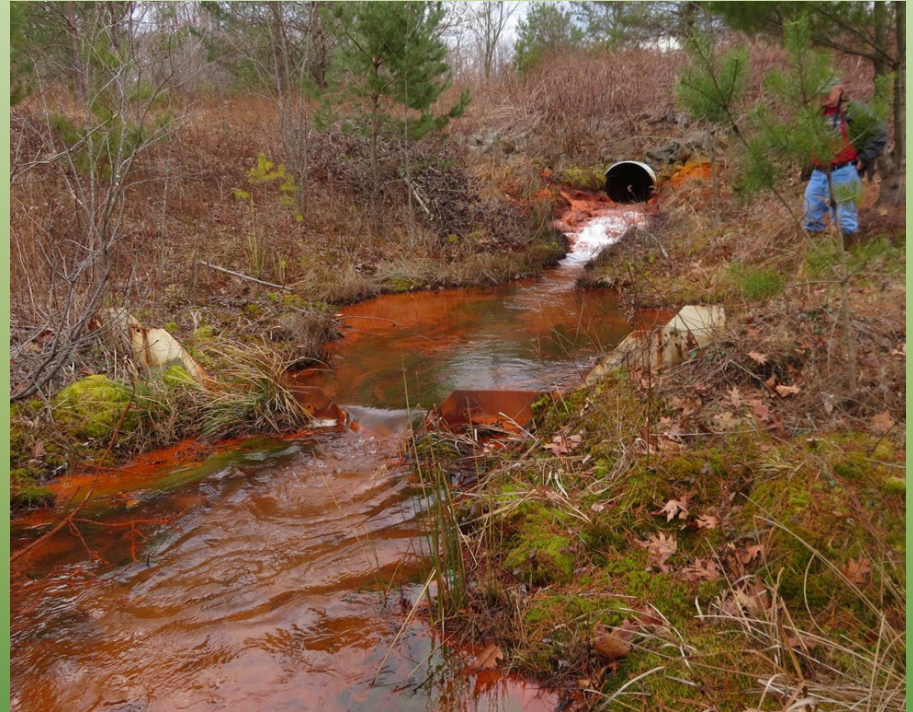
Impacted Stream Segment #89:

- Colbert Mine Discharge
- Heavy contamination of metals
- Discharge has pH range of 5.68 to 5.86

- Remining, reclamation and limiting flow to the mine pool
- Treatment of the mine discharge

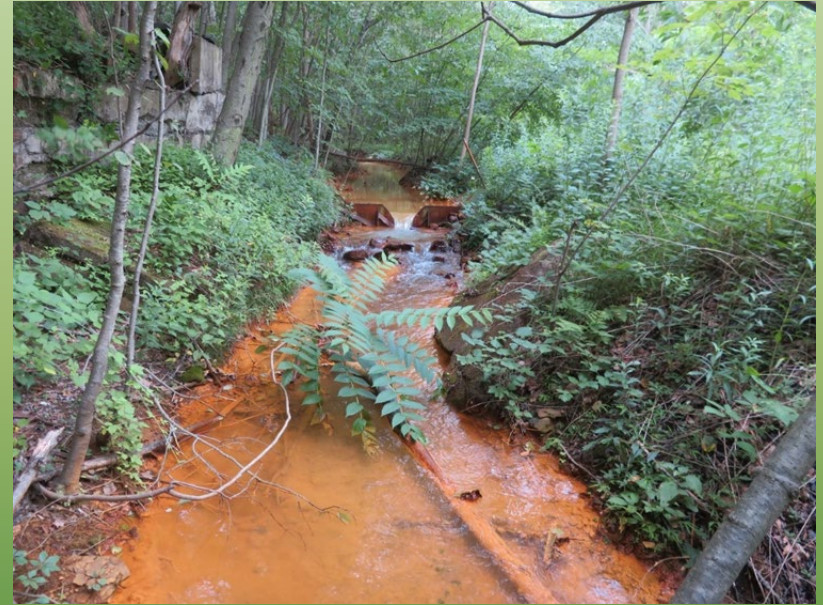
Impacted Stream Segment #67-71:

- The Big Mountain Discharge is the principal contributor to Buck Run flow
- Heavy contamination of metals
- Average pH of 4.40

- Remining, reclamation and limiting flow to the mine pool
- Treatment of the mine discharge

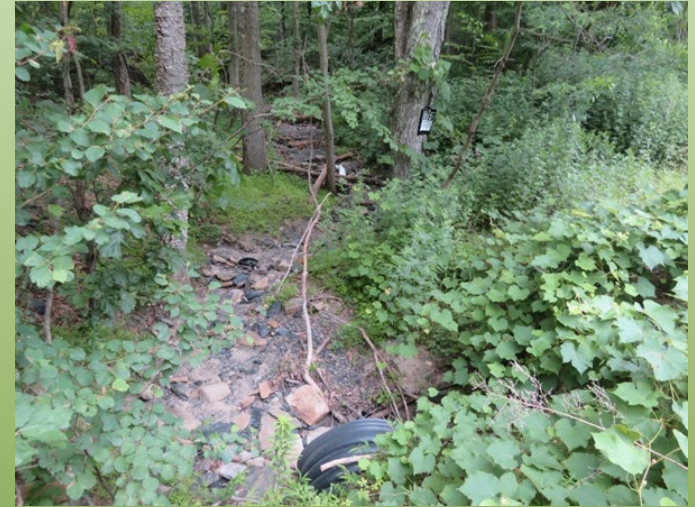
Quaker Run and Buck Run Reclamation:

- Bulk of the watershed has been impacted by surface and/or deep mining for anthracite coal
- Metals and siltation from the abandoned deep mine discharges and waste coal piles
- Highly disturbed headwaters of both Quaker Run and Buck Run

- Continued reclamation of mine scarred lands
- Remining of areas where abandoned deep mines can be eliminated
- Removal of culm (waste coal) piles
- Reduction of water infiltration into existing mine pools
- Treatment of abandoned mine drainage discharges
