# Shamokin Creek Watershed Mine Drainage Overview GEOL 305

Bucknell University

Carl Kirby

**Effects of Abandoned Coal-Mine Drainage  
on Streamflow and Water Quality in the  
Shamokin Creek Basin,  
Northumberland and Columbia Counties,  
Pennsylvania, 1999-2001**

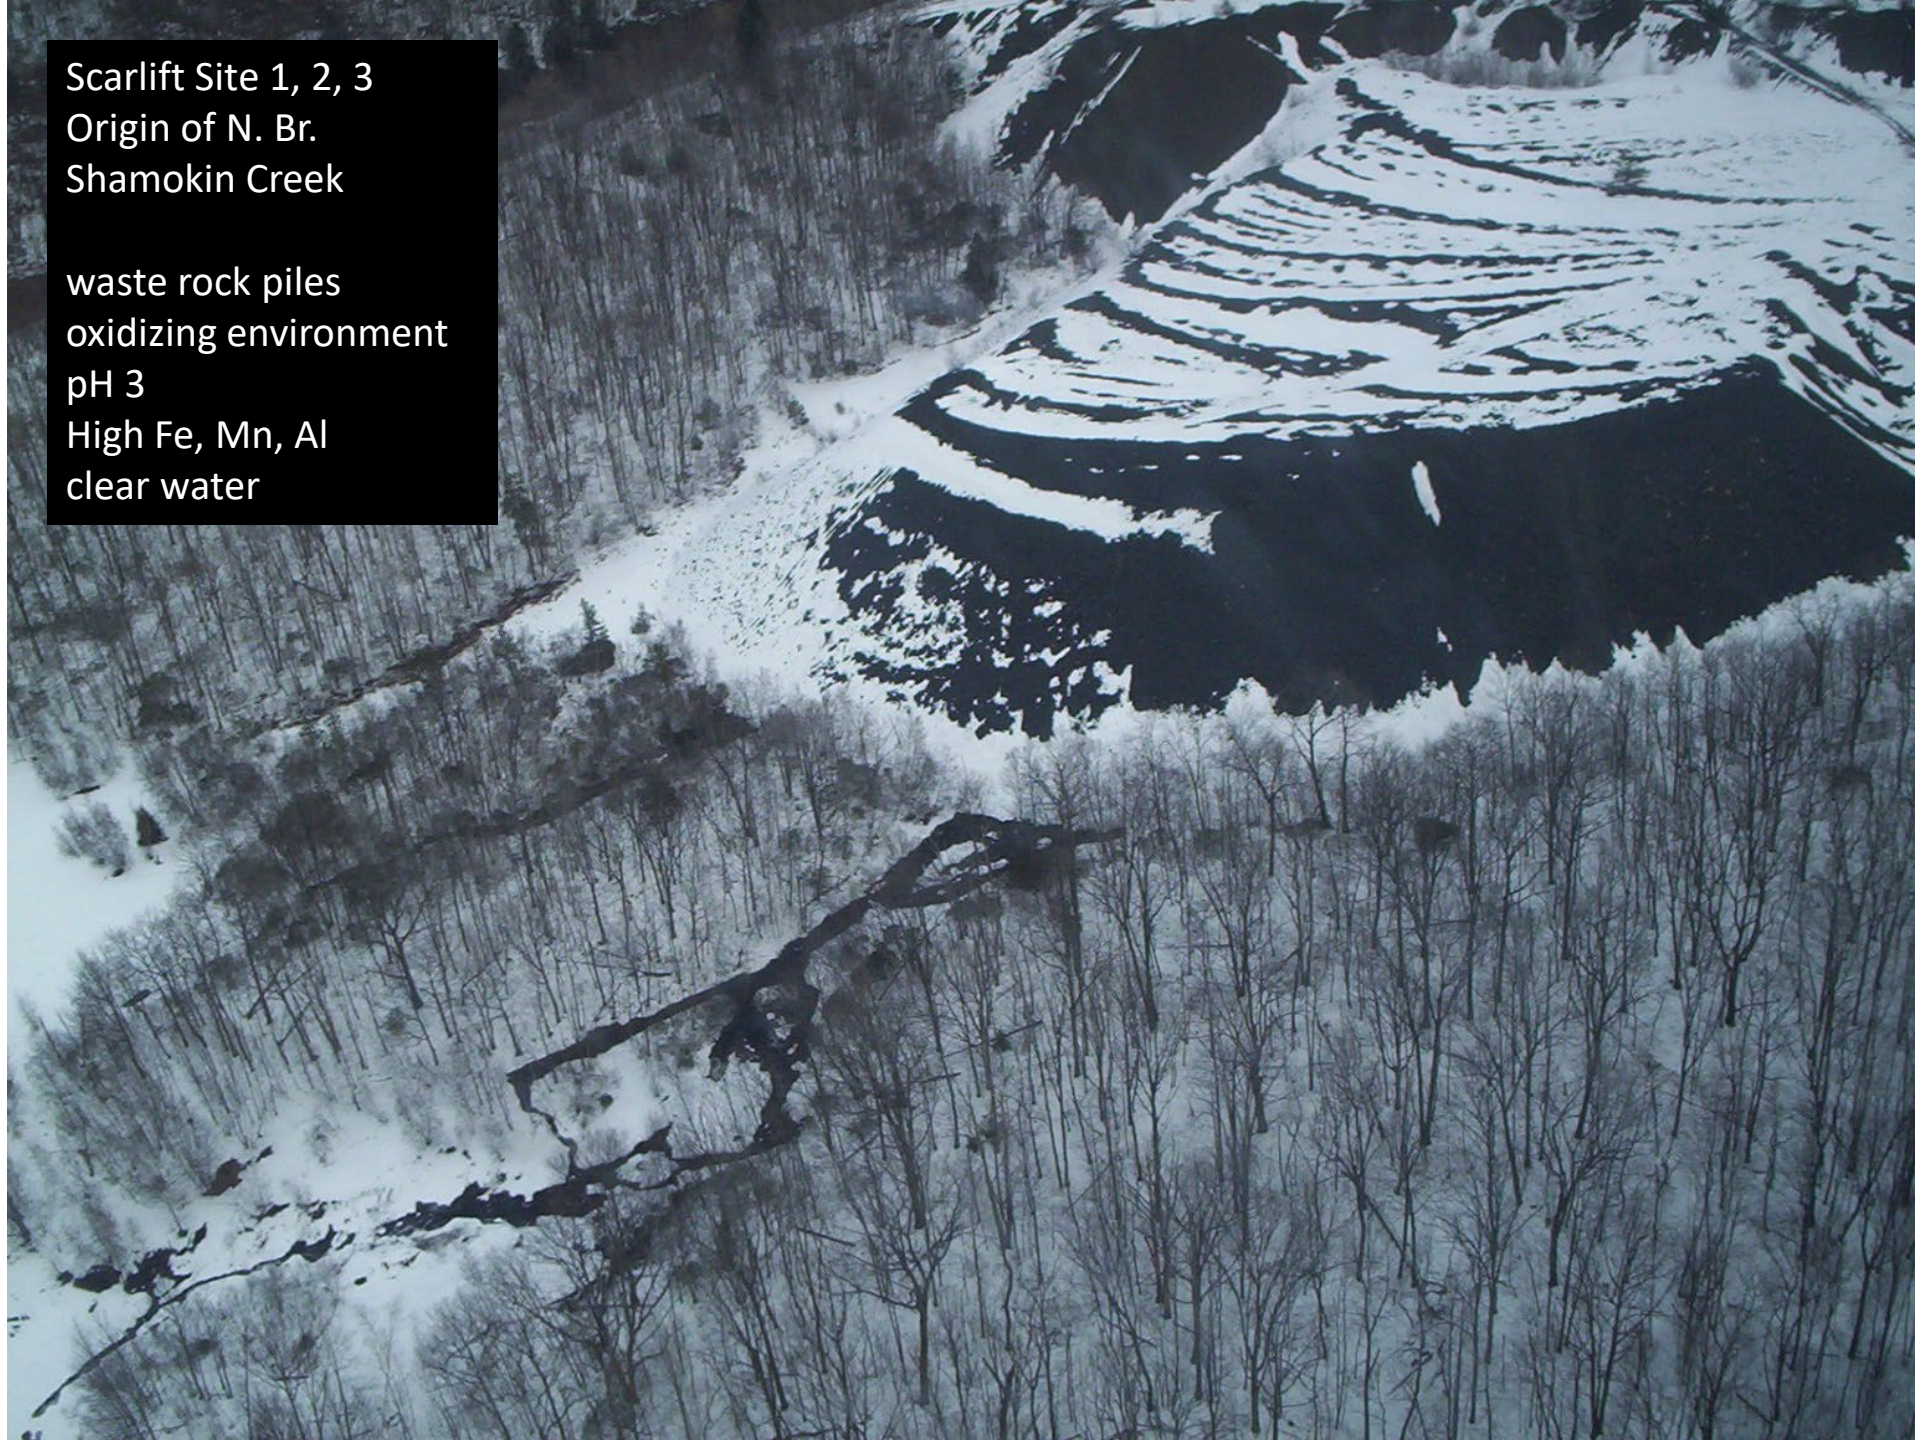
Scarlift Site 1, 2, 3  
Origin of N. Br.  
Shamokin Creek

waste rock piles  
oxidizing environment  
pH 3  
High Fe, Mn, Al  
clear water

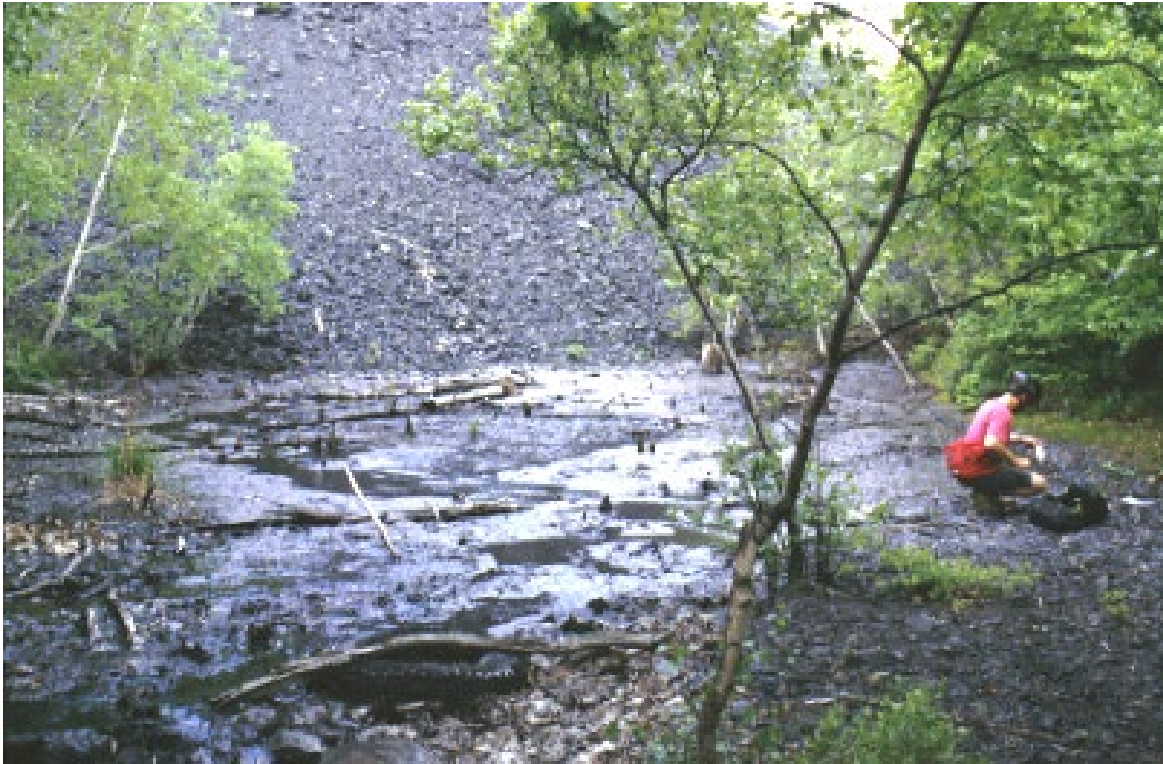
Brad Jordan at Scarlift Site 2 discharge  
From a large aerated spoils pile

- pH 3
- high Fe, Al, Mn
- net acidic
- clear water

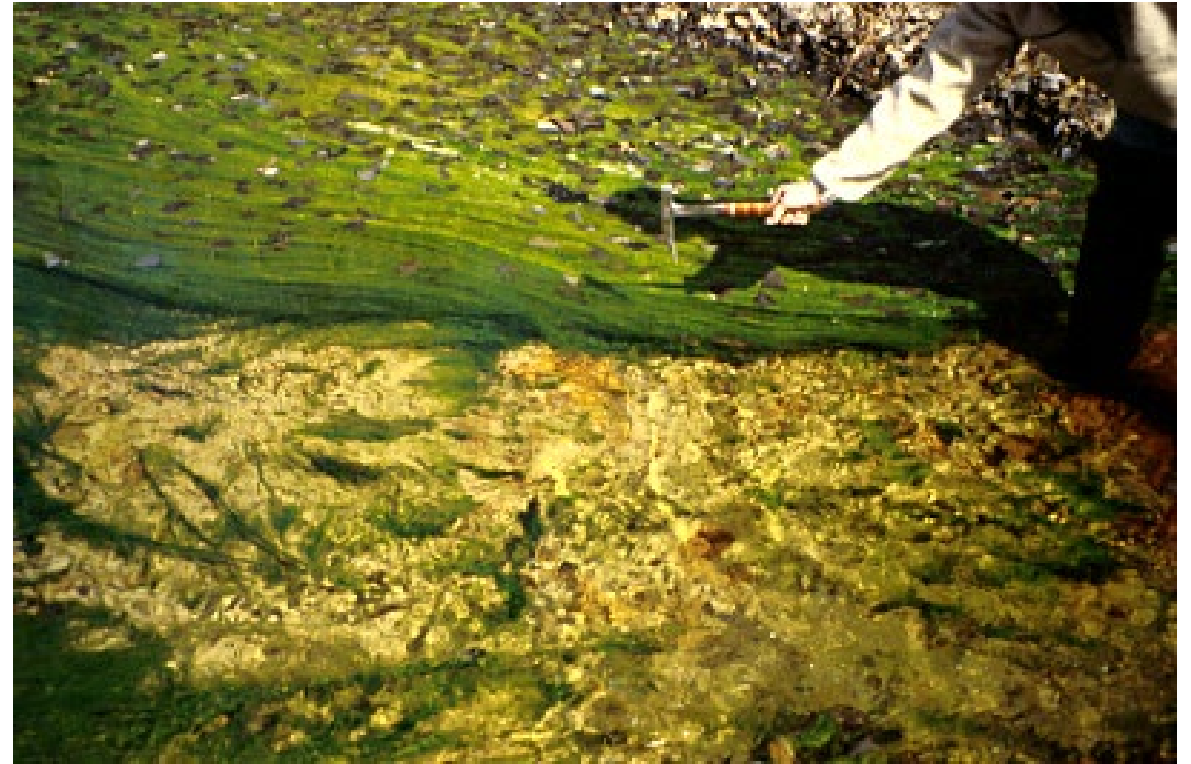
Scarlift Site 4  
Luxuriant algae growth – not much living to eat it  
From deep mine & spoils pile

- pH 3.5
- high Fe, Al, Mn
- net acidic
- clear water

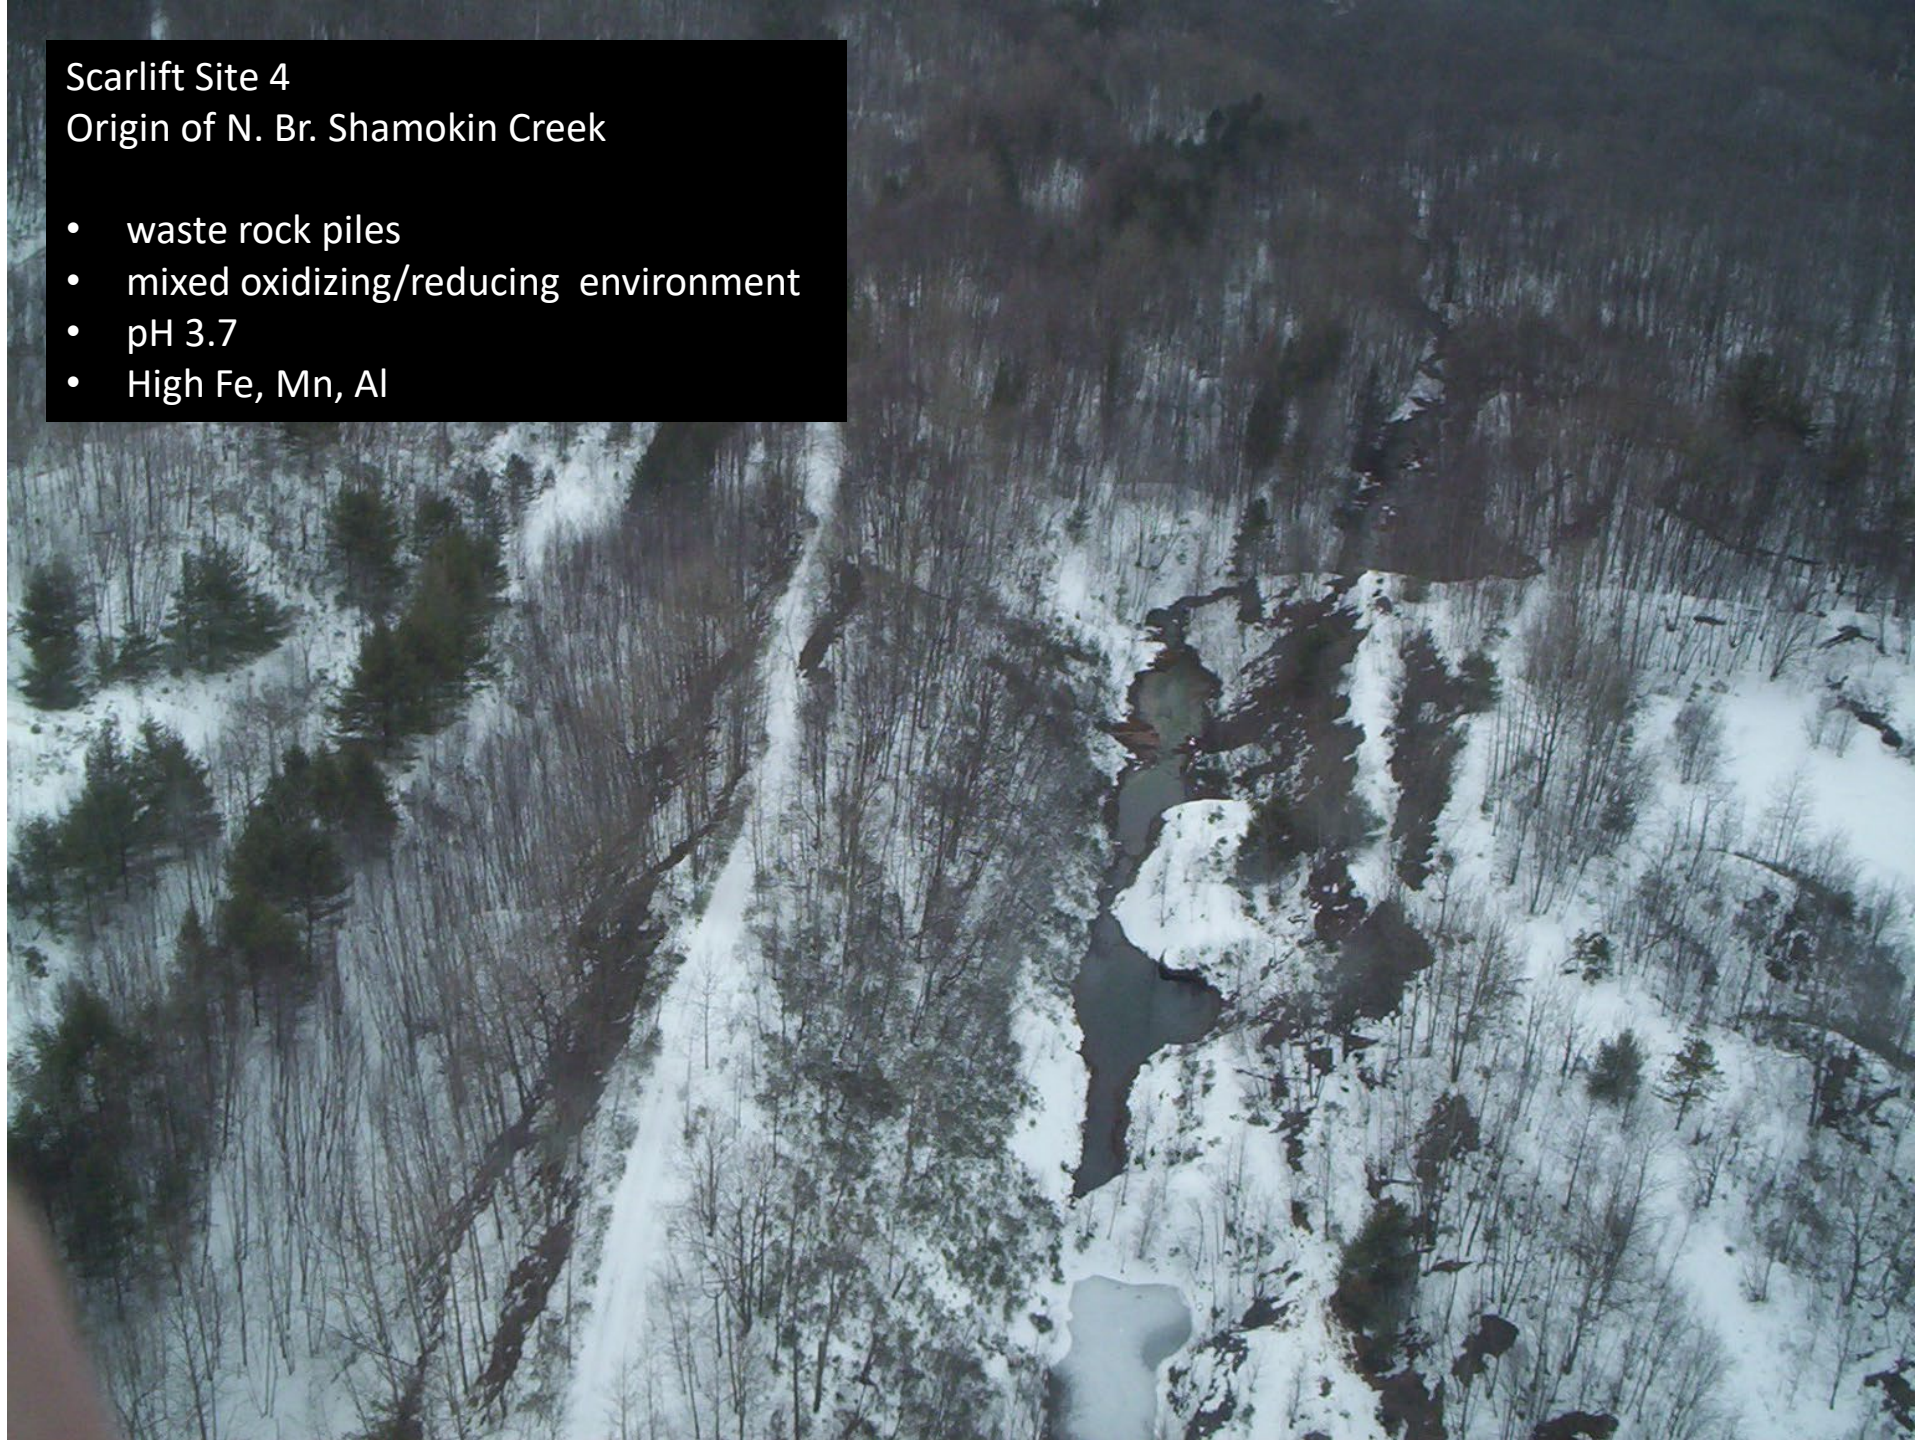
## Scarlift Site 4

- waste rock piles
- mixed oxidizing/reducing environment
- pH 3.7
- High Fe, Mn, Al

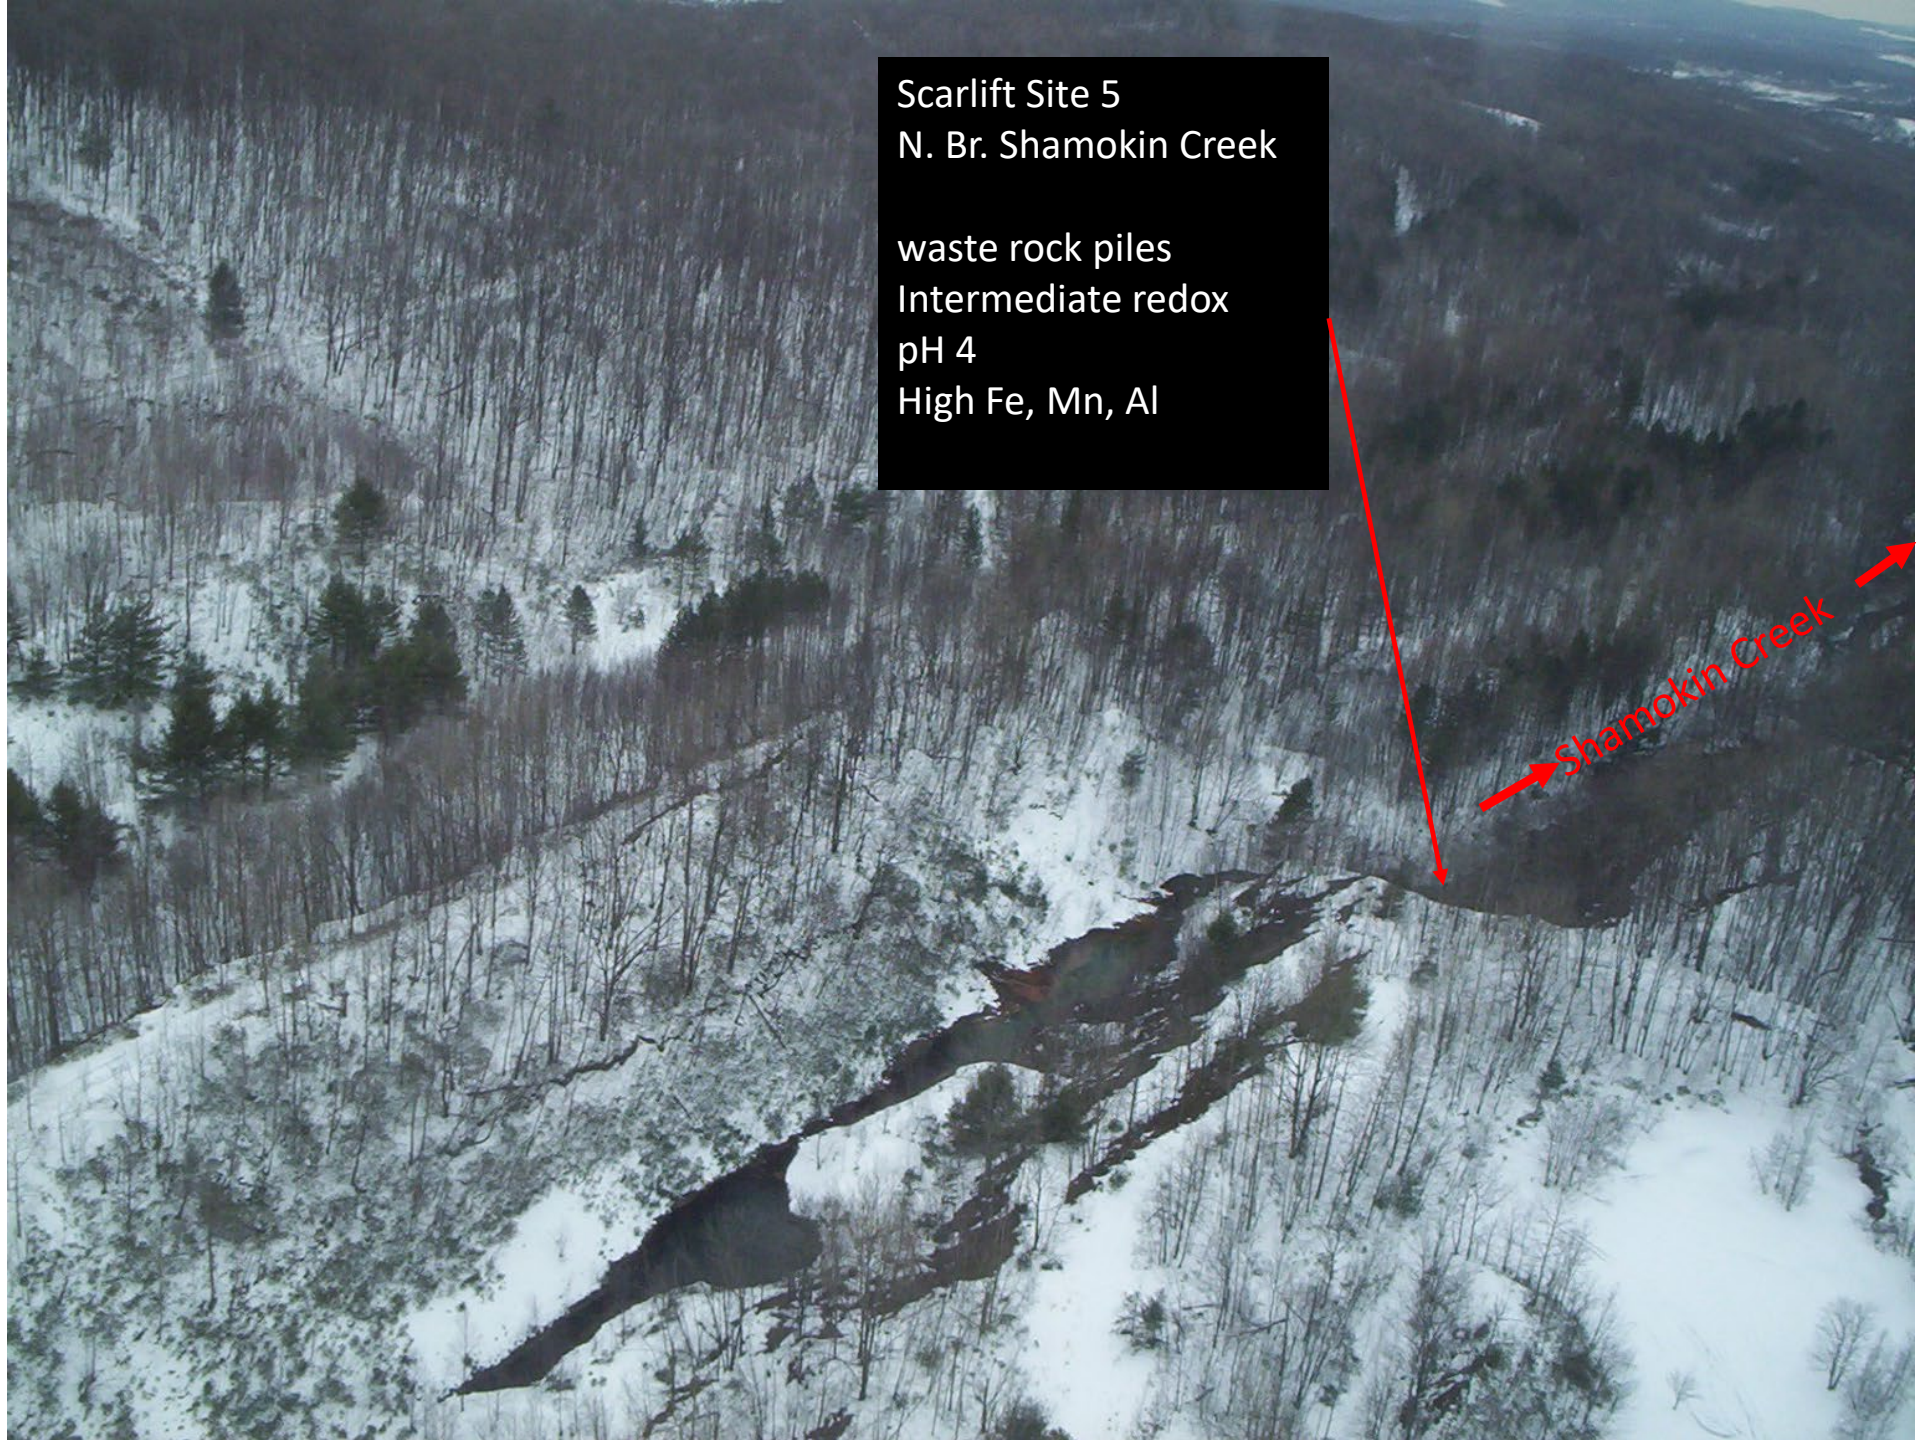
Scarlift Site 5  
N. Br. Shamokin Creek

waste rock piles  
Intermediate redox  
pH 4  
High Fe, Mn, Al

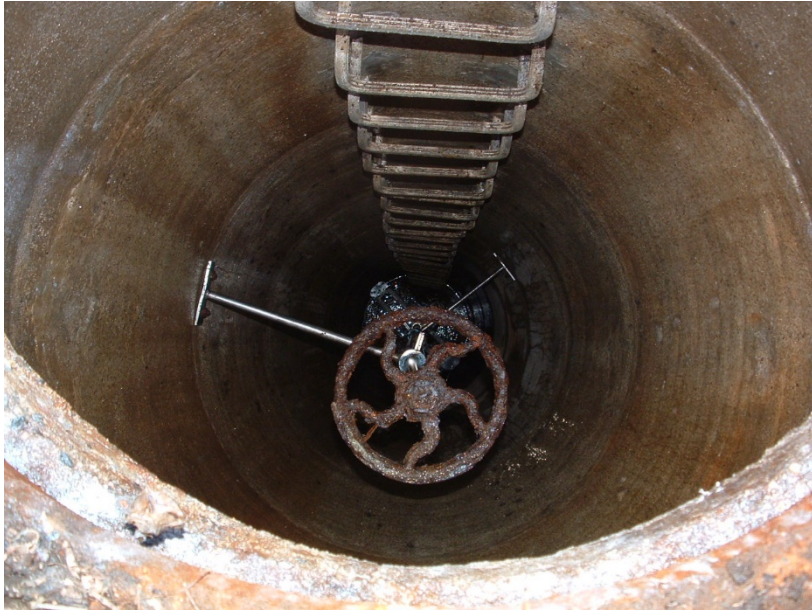
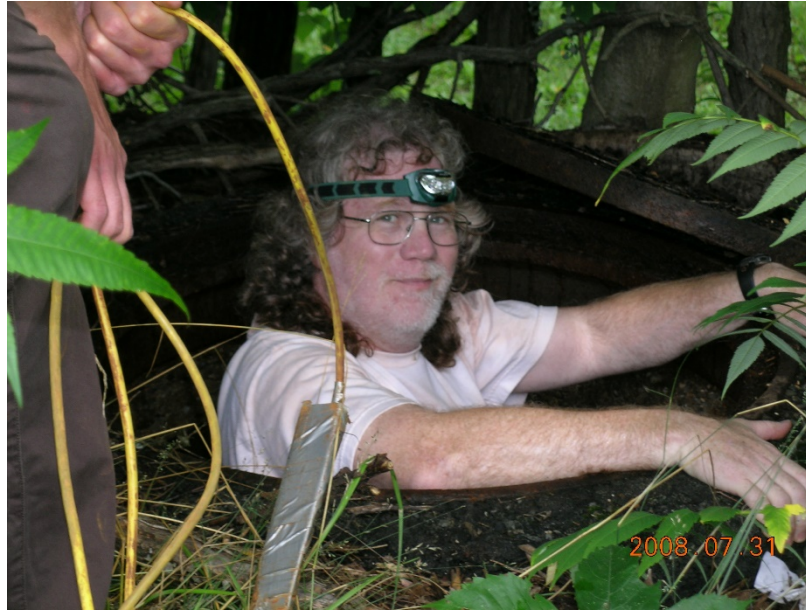
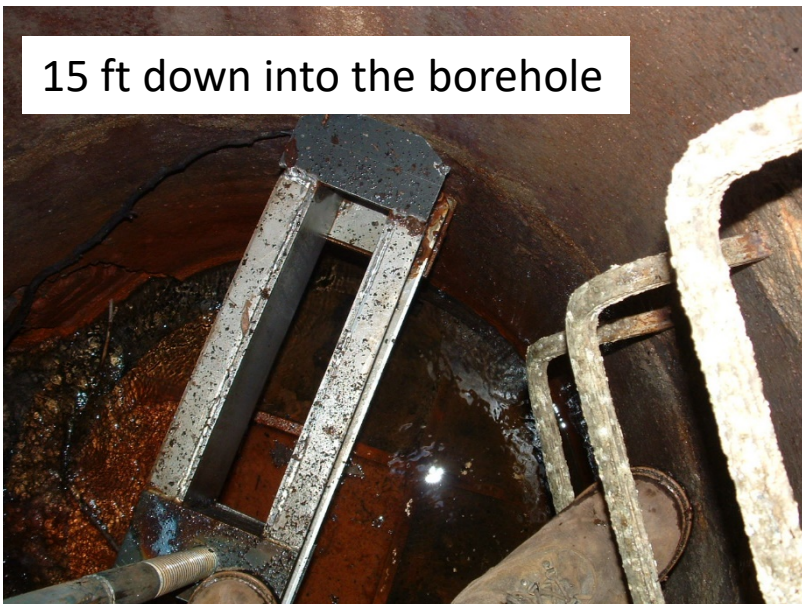
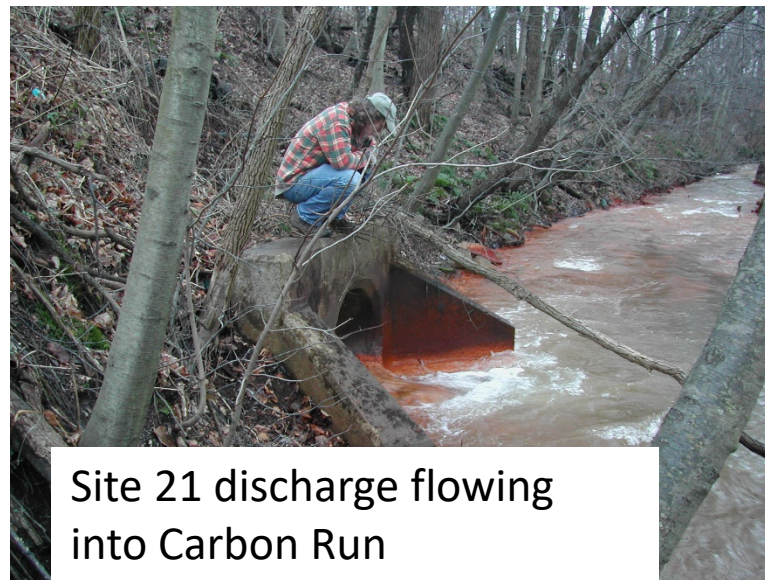
# Scarlift Site 21 – Ranshaw, PA - deep mine discharge

Figure 1. Aerial photograph with land ownership near proposed Site 21 treatment.

- 0.5 cfs
- pH 6.1
- high Fe
- low Al
- net alkaline

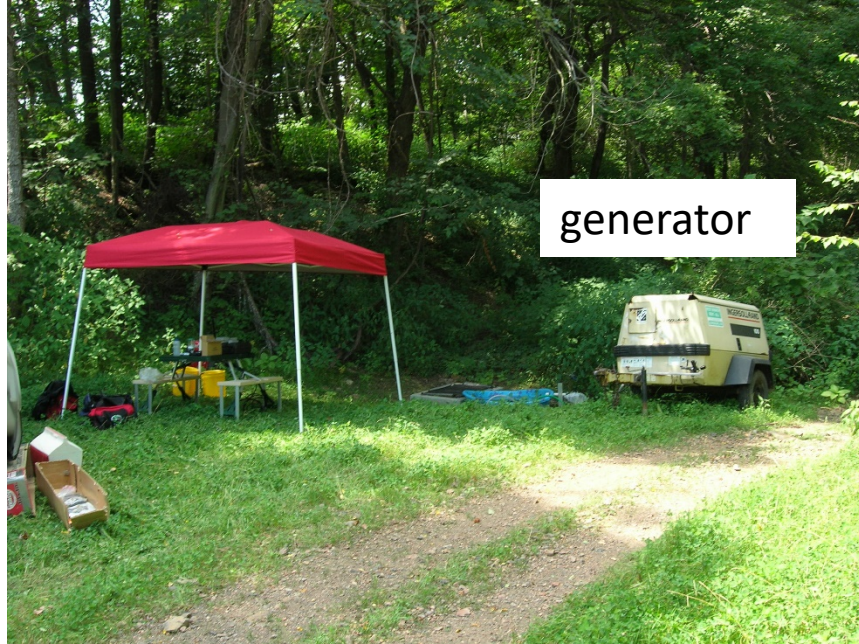
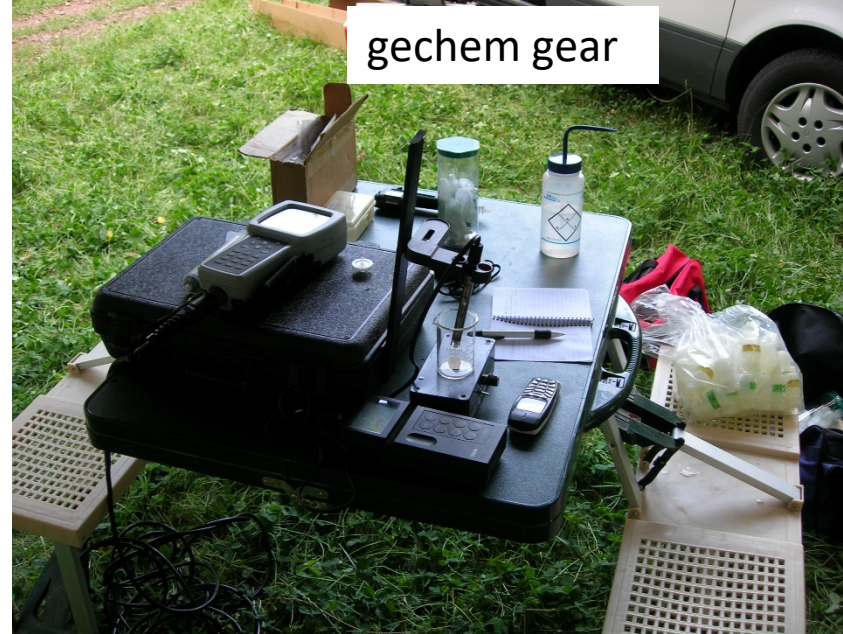
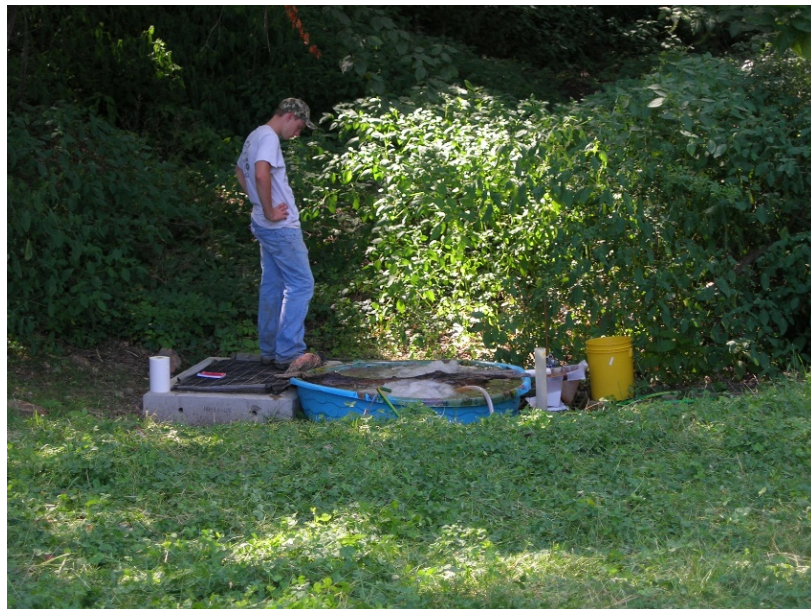
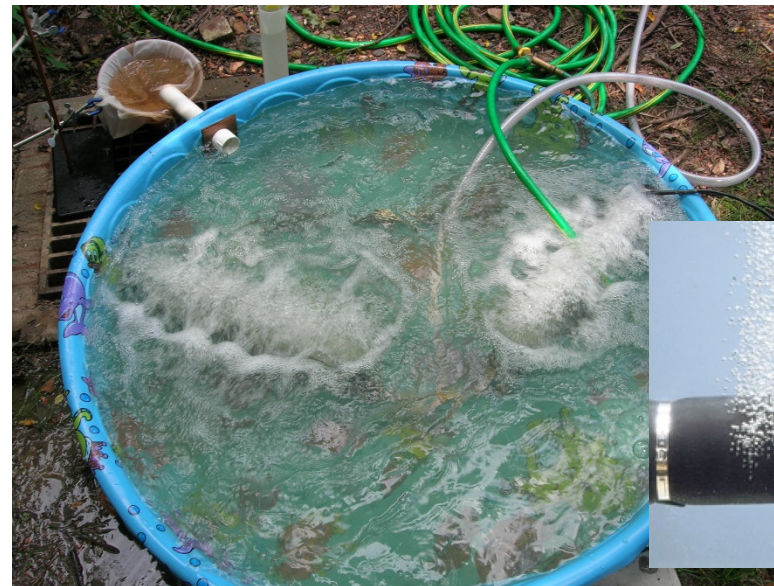
# Scarlift Site 21 – Ranshaw, PA – Fe(II) oxidation rate experiments – stage 2

Could be treated with aeration alone; would require pumping and area to capture solids; no limestone needed

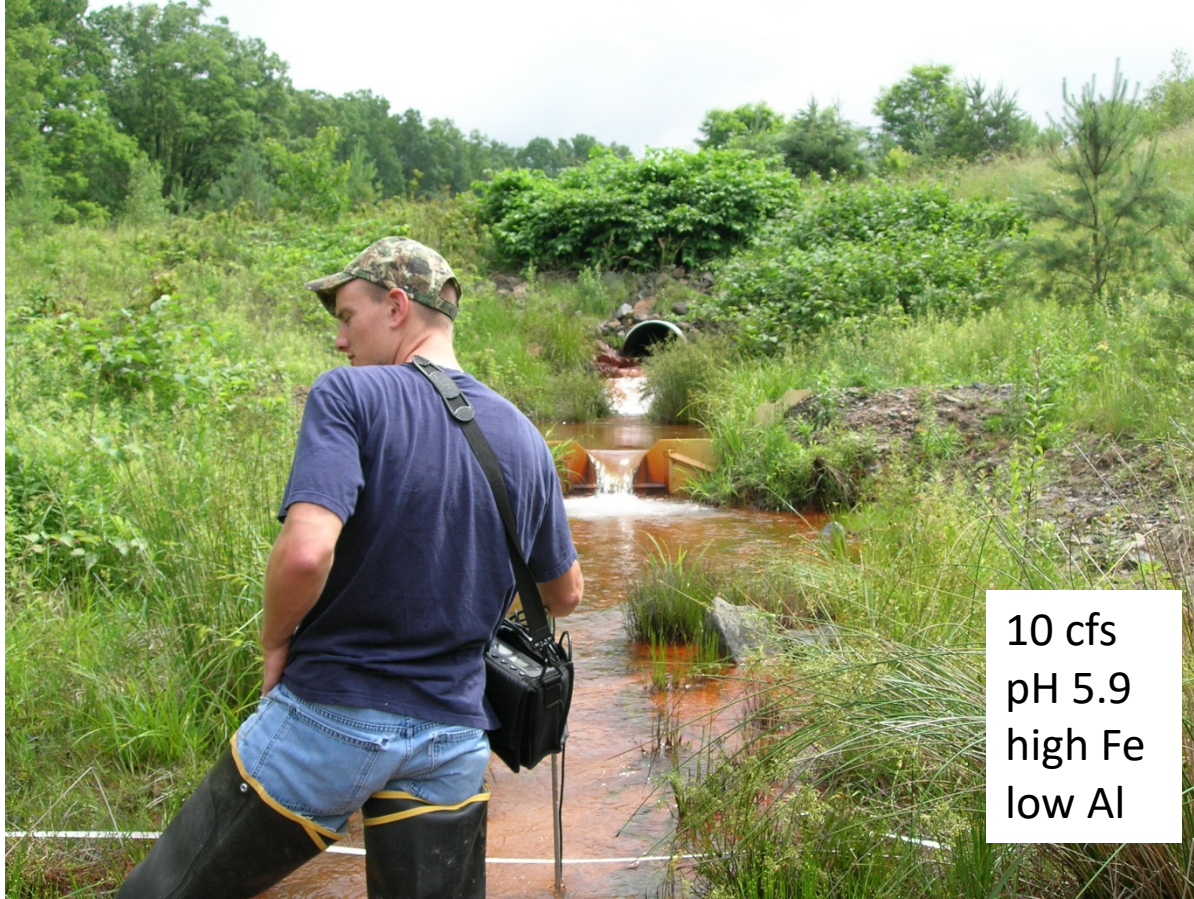
Scarlift Site 19

10 cfs  
pH 5.9  
high Fe  
low Al

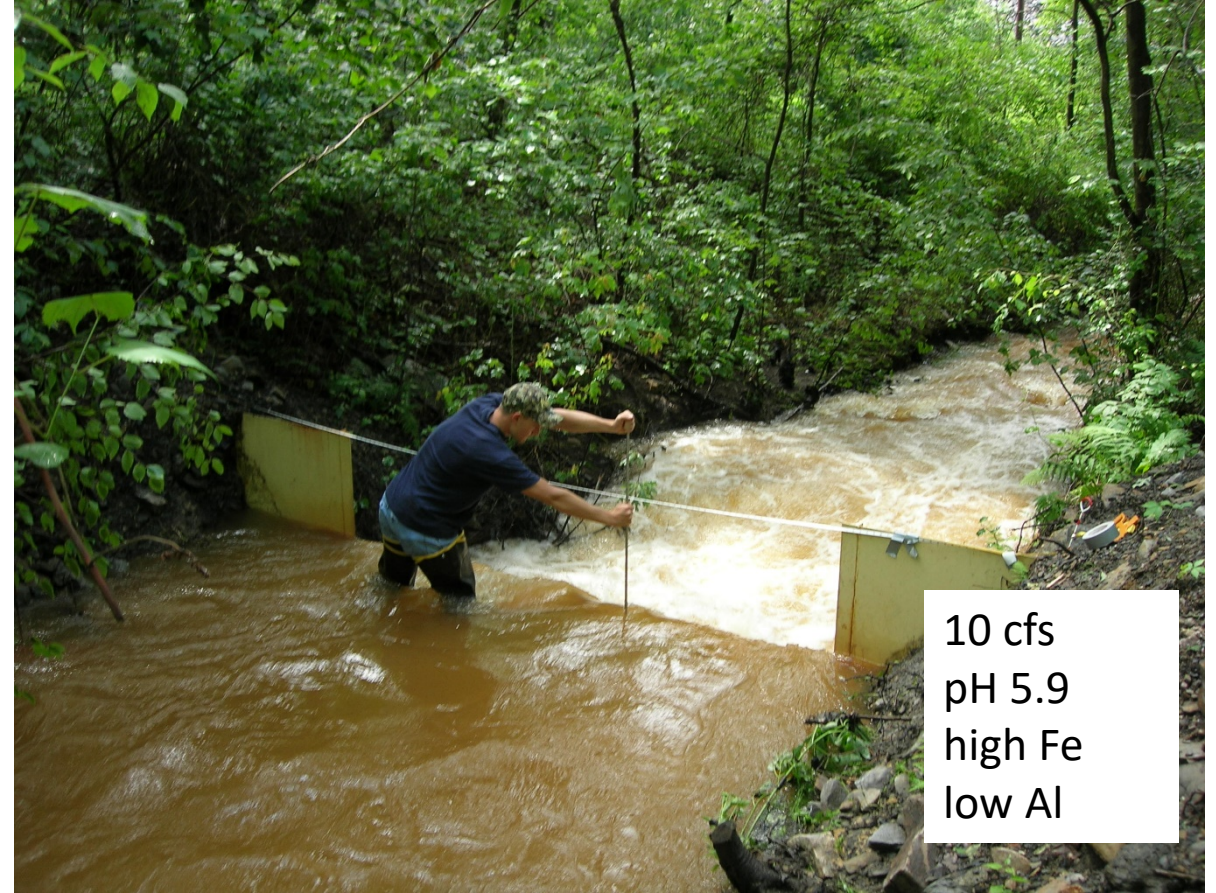
Scarlift Site 20 6/27/2006 flooding

10 cfs  
pH 5.9  
high Fe  
low Al

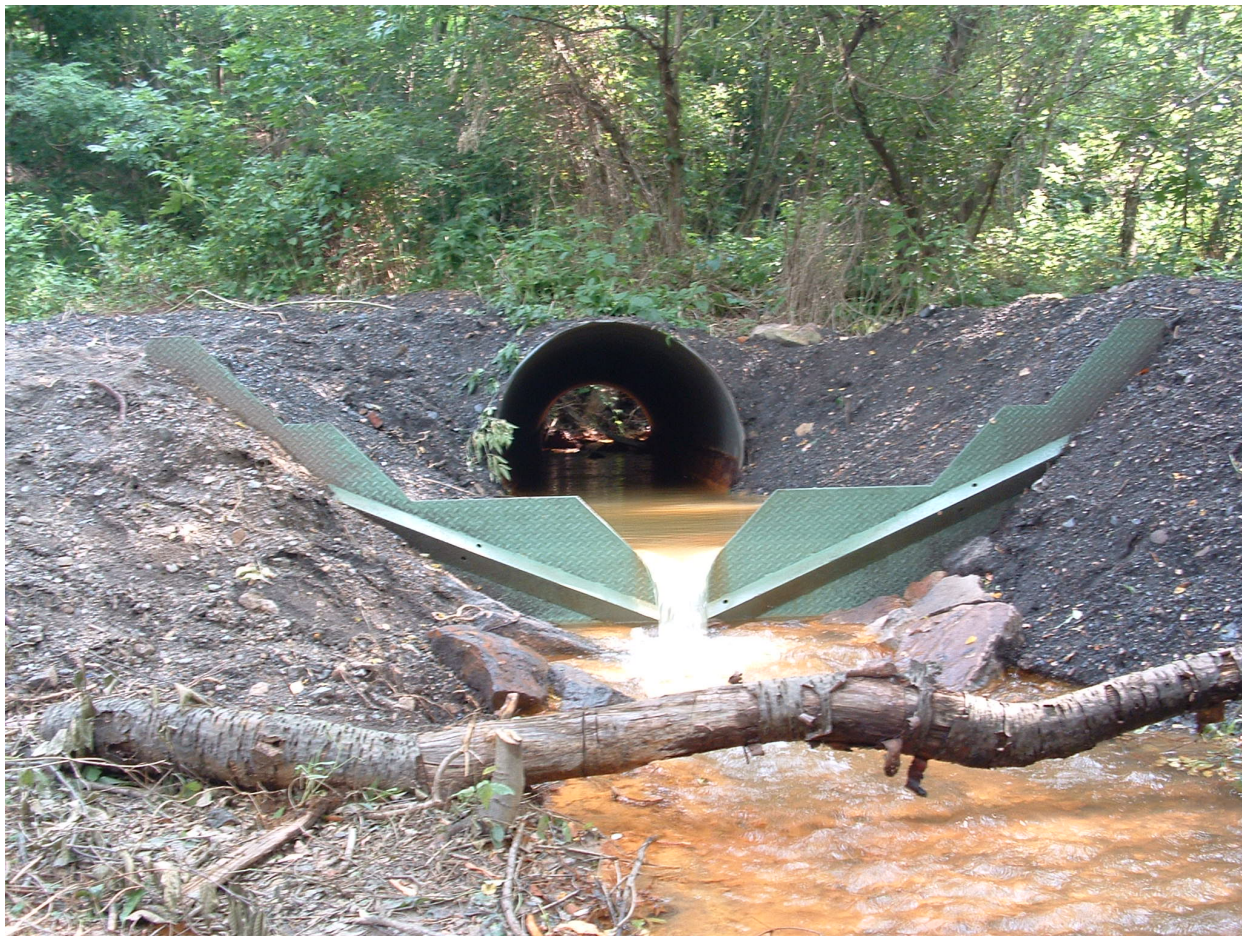
Scarlift Site 36 – 0 (usually) to 2 mgd flow  
Double V-notch weir for flowrate measurement

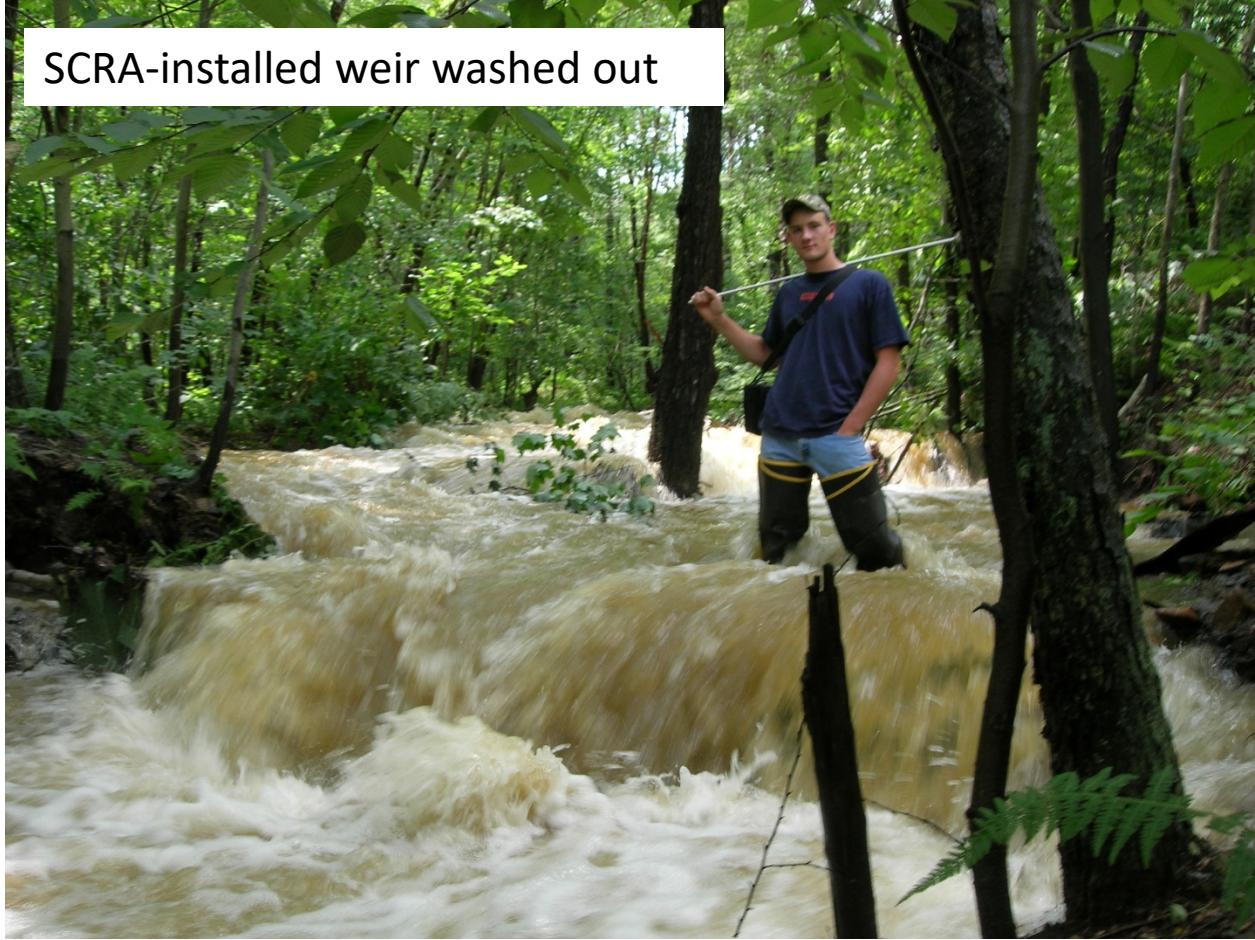
Scarlift Site 23 – Ranshaw, PA

SCRA-installed weir washed out

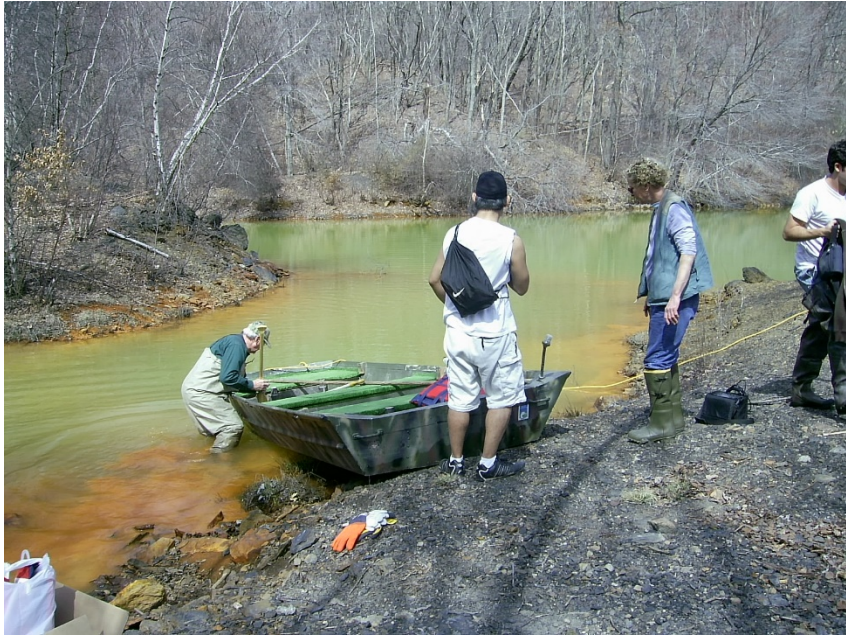
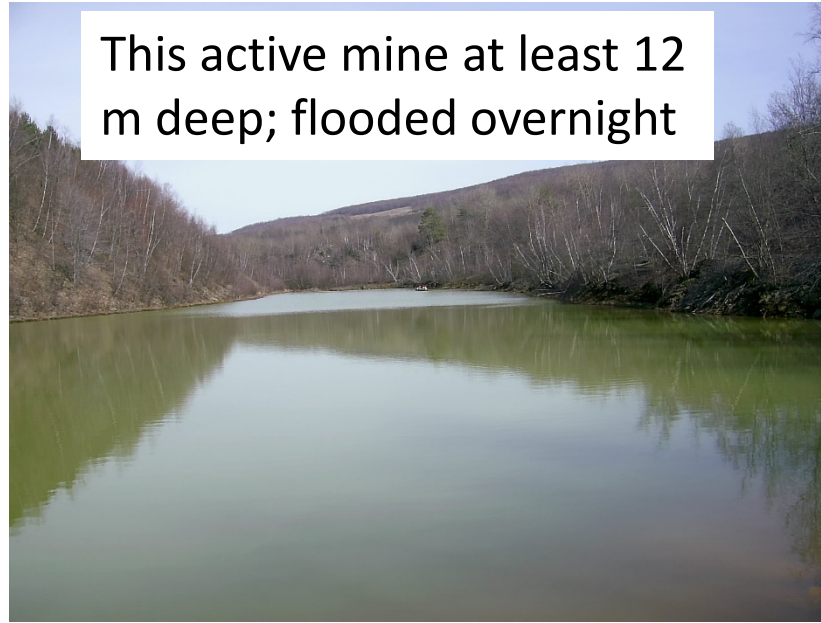
Scarlift Site 12– Excelsior, PA - largest discharge in watershed; avg 12 mgd

This active mine at least 12 m deep; flooded overnight

- 7 cfs
- pH 5.8
- reducing conditions
- high Fe
- low Al
- just net acidic

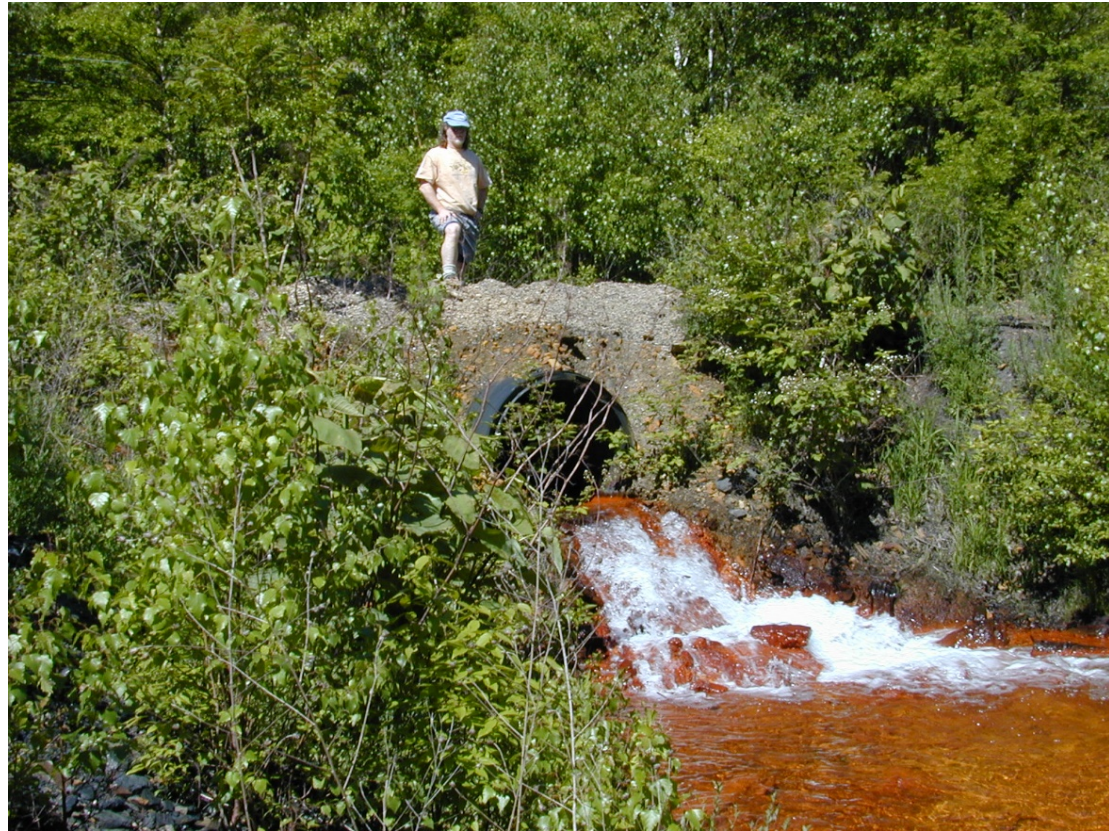
Scarlift Site 51 just upstream of Shamokin Creek  
near spoils pile north of Shamokin

- 1 cfs
- pH 5
- high Fe, Al, Mn
- net acidic

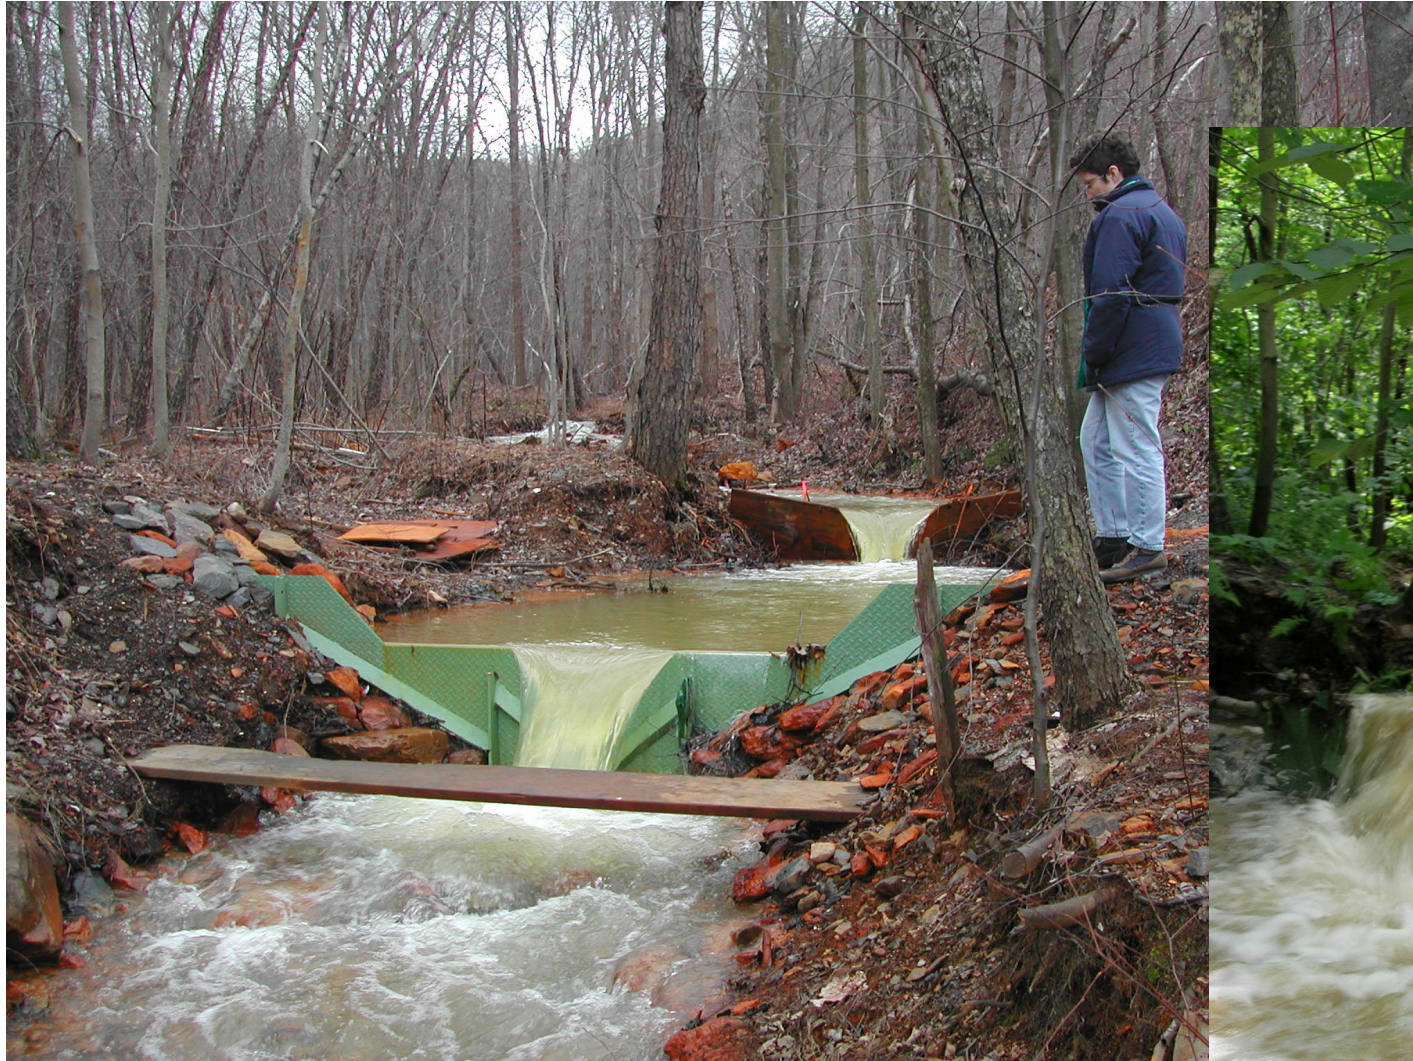
Scarlift Site 23 – Double v-notch weir replacing damaged upstream wooden weir
