# Shamokin Creek Watershed Mine Drainage Overview GEOL 305

Bucknell University

Carl Kirby

**Effects of Abandoned Coal-Mine Drainage  
on Streamflow and Water Quality in the  
Shamokin Creek Basin,  
Northumberland and Columbia Counties,  
Pennsylvania, 1999-2001**

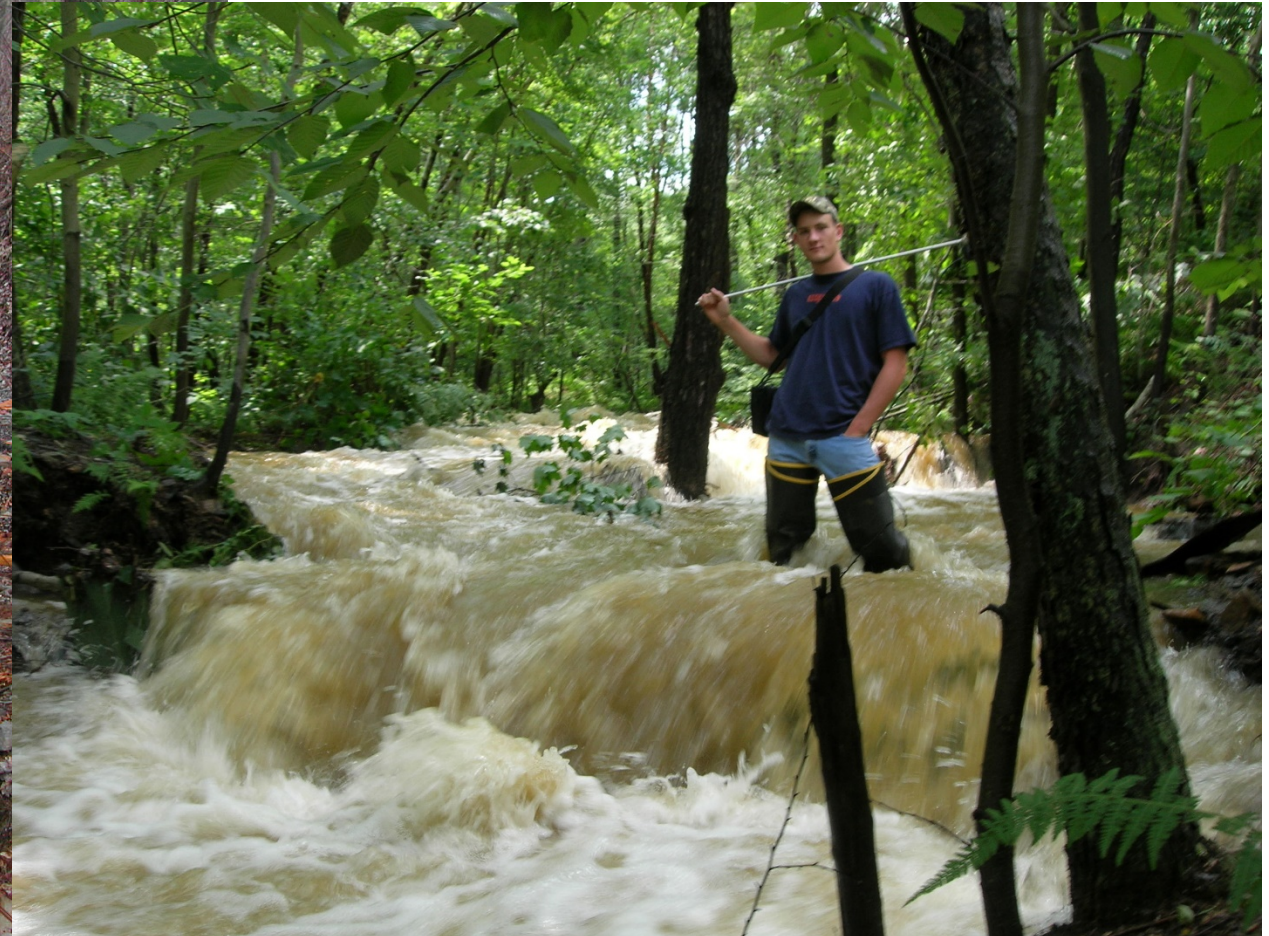
Metal V-notch weir damaged 6/27/06 flood

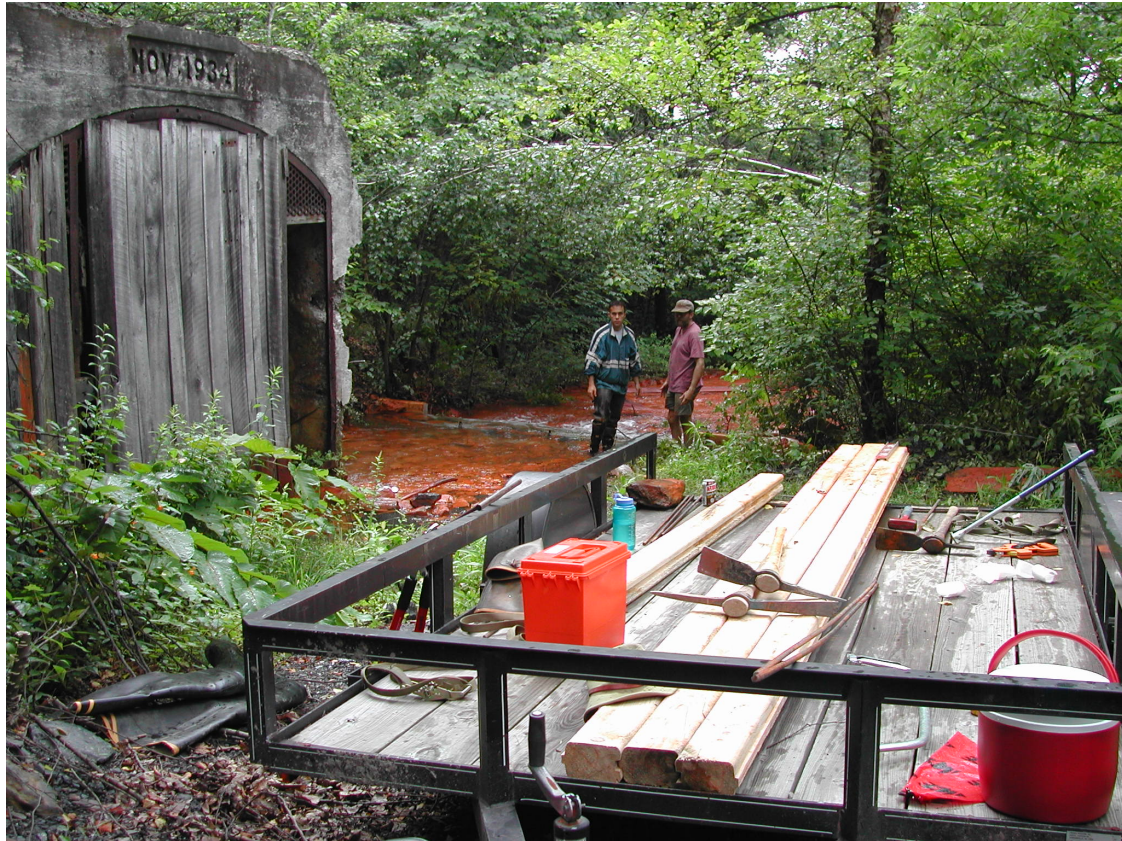
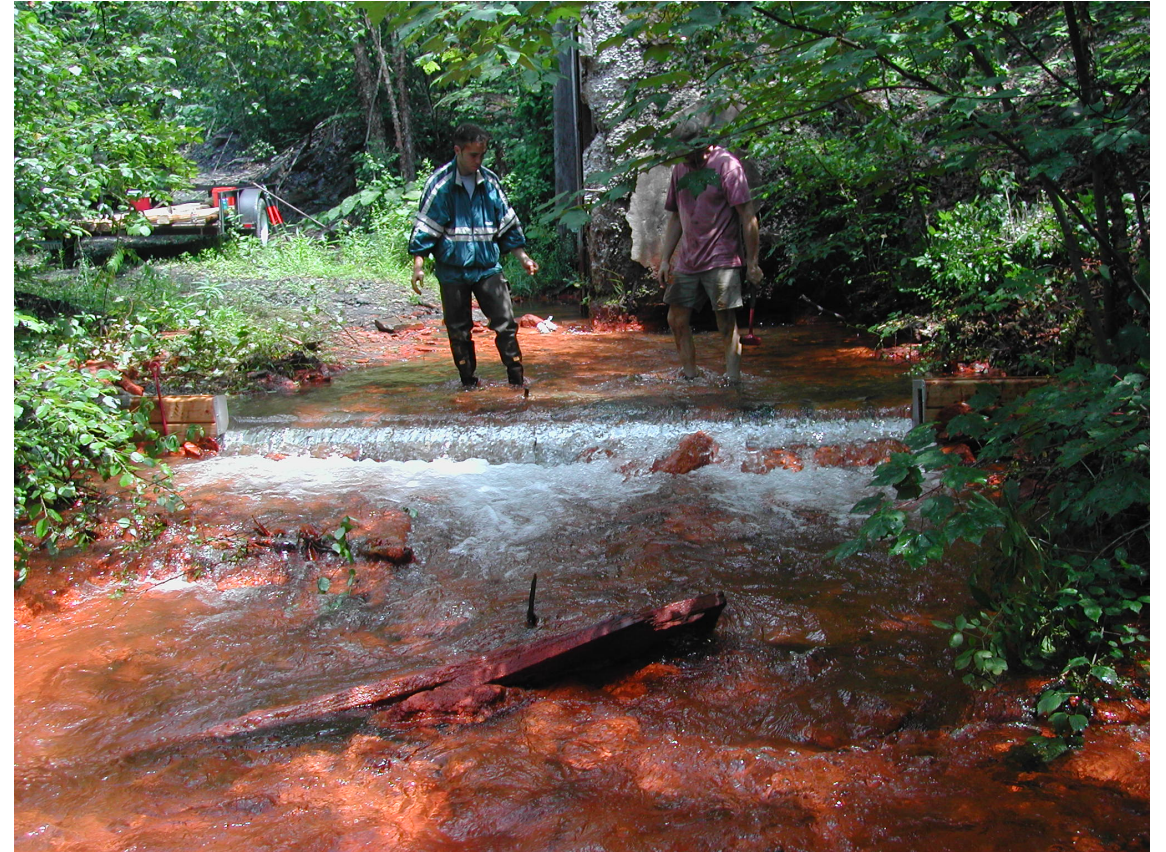
Scarlift Site 49 (pump slope) - building a rectangular weir for flowrate

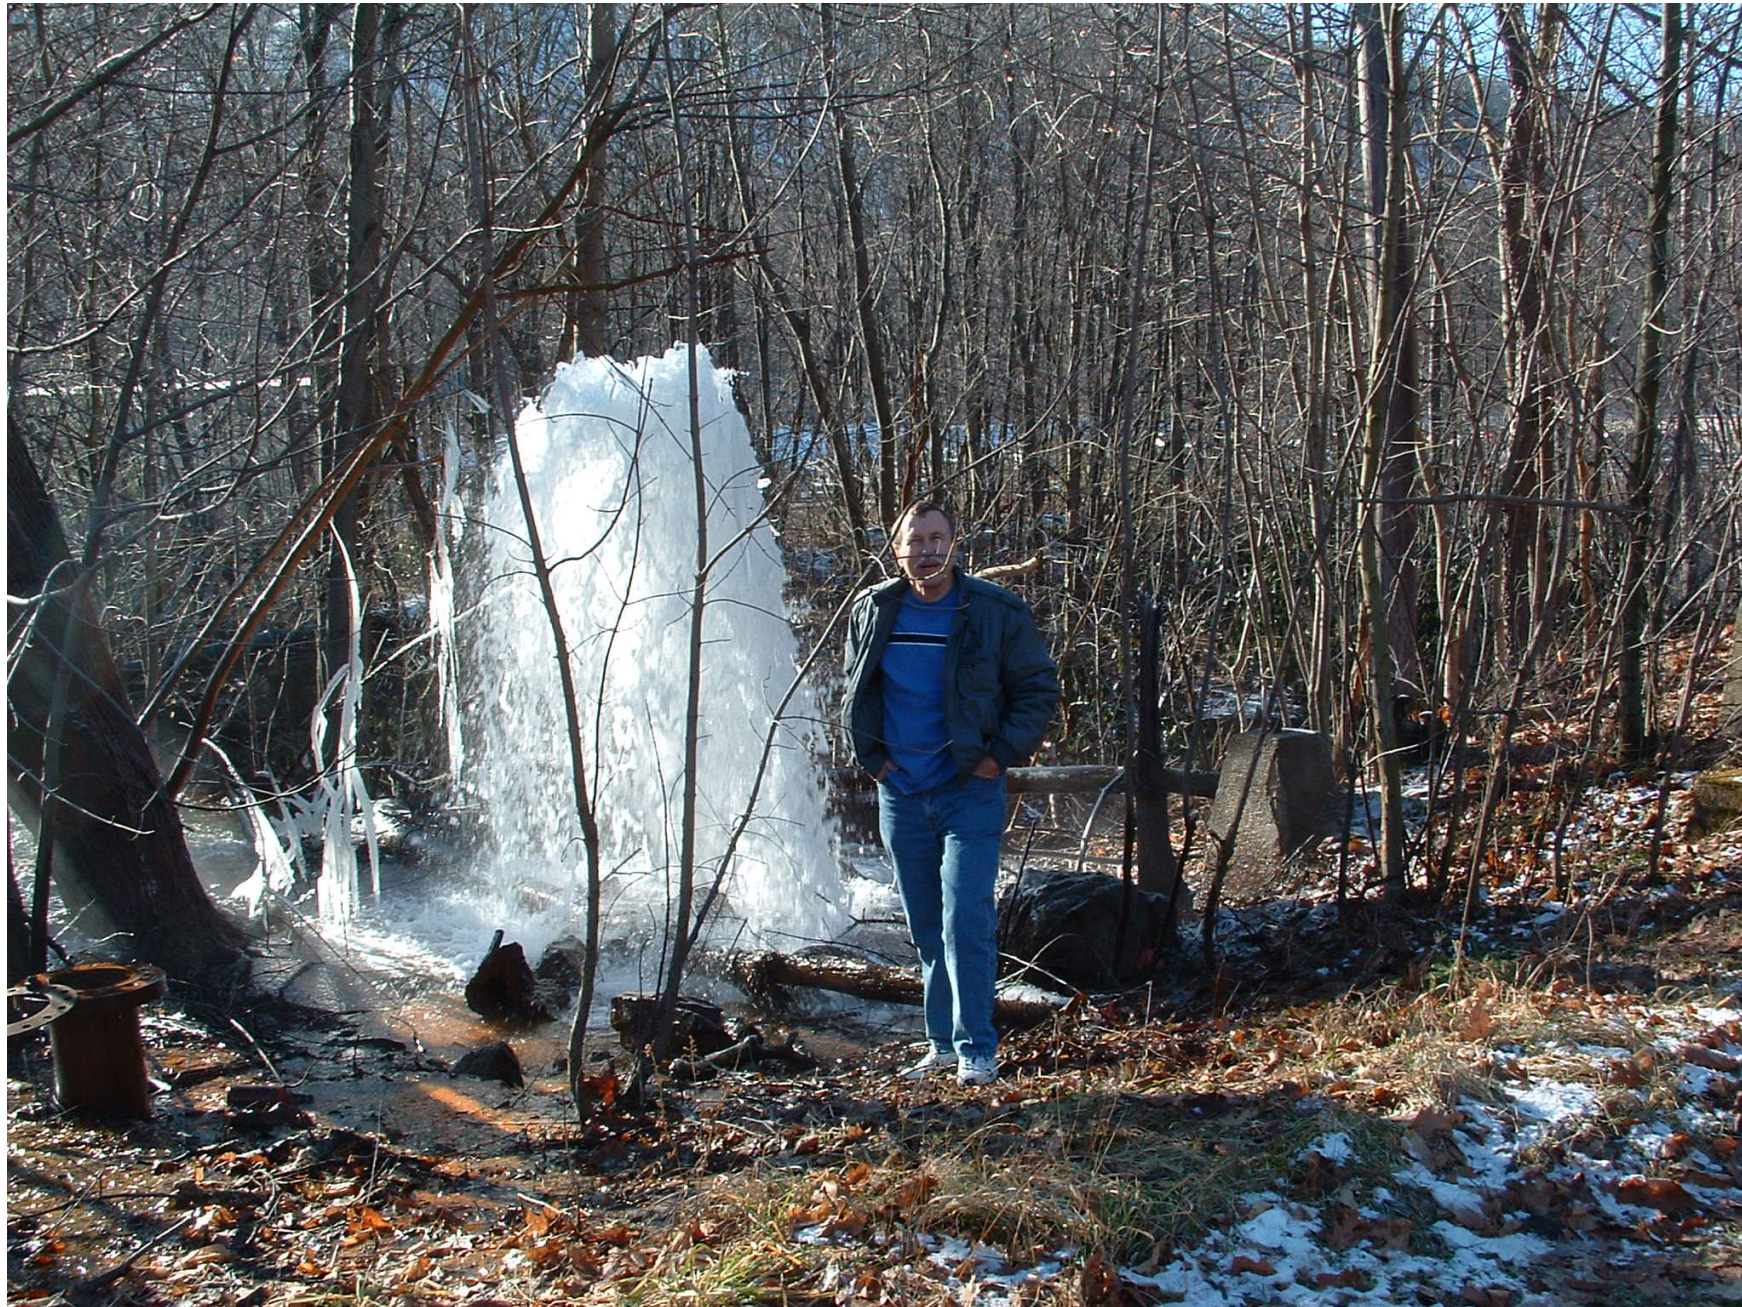
Ashland Borehole discharge – south of Shamokin Creek watershed – quite artesian

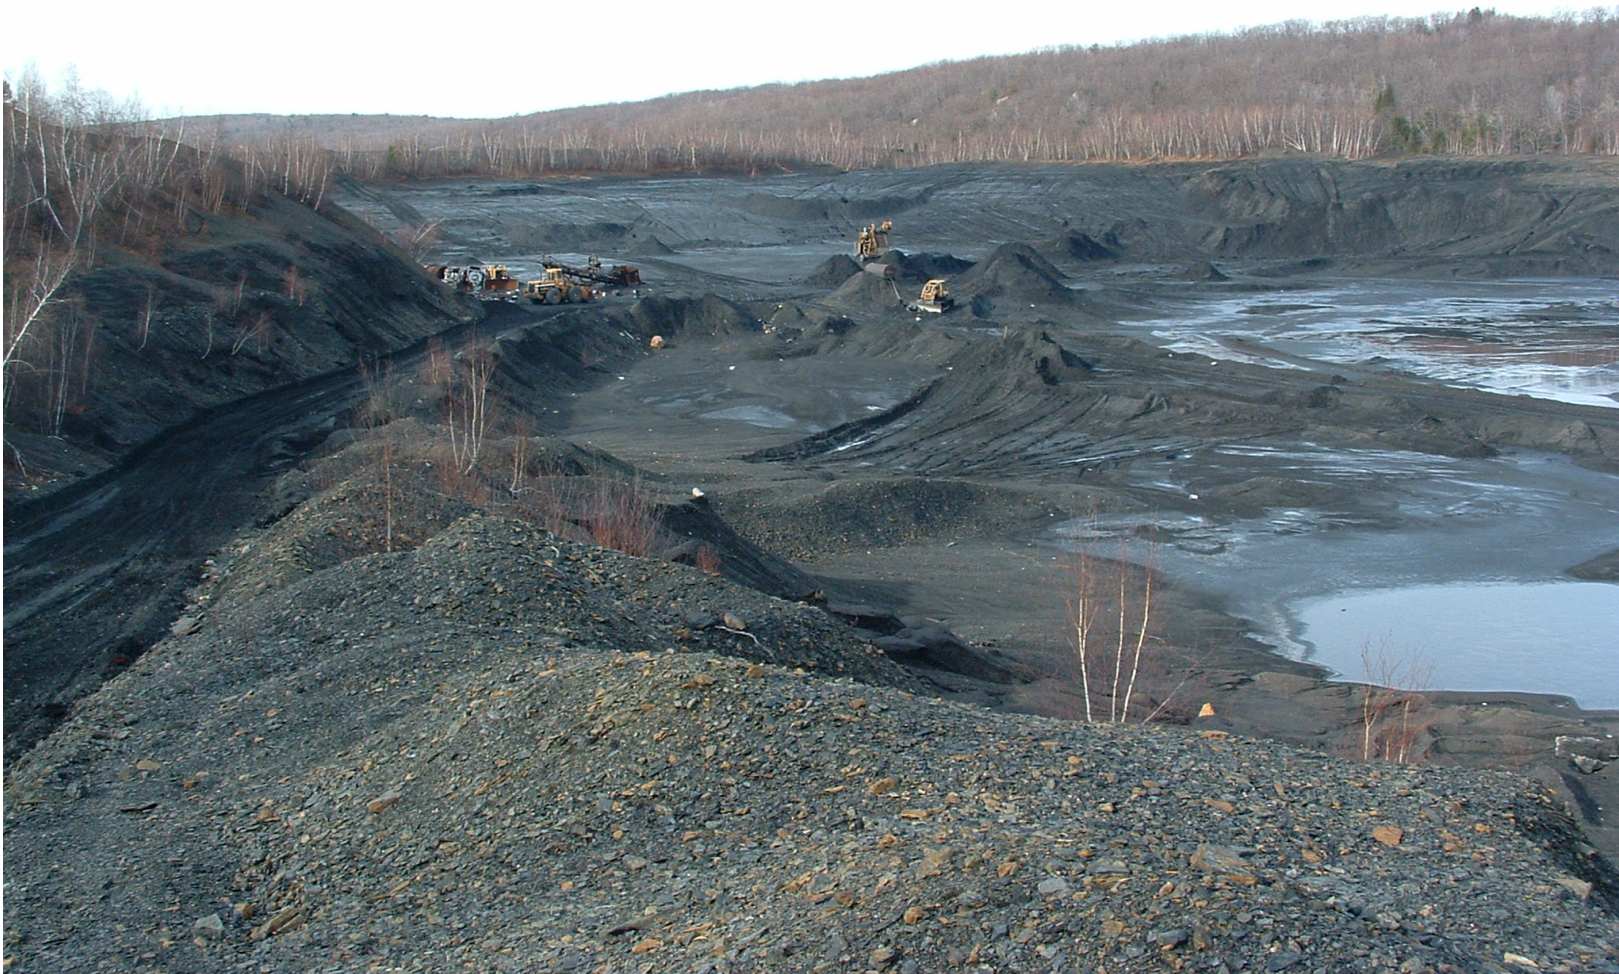
Remining (removal of spoils to burn producing electricity) removes pyritic material, helps prevent AMD

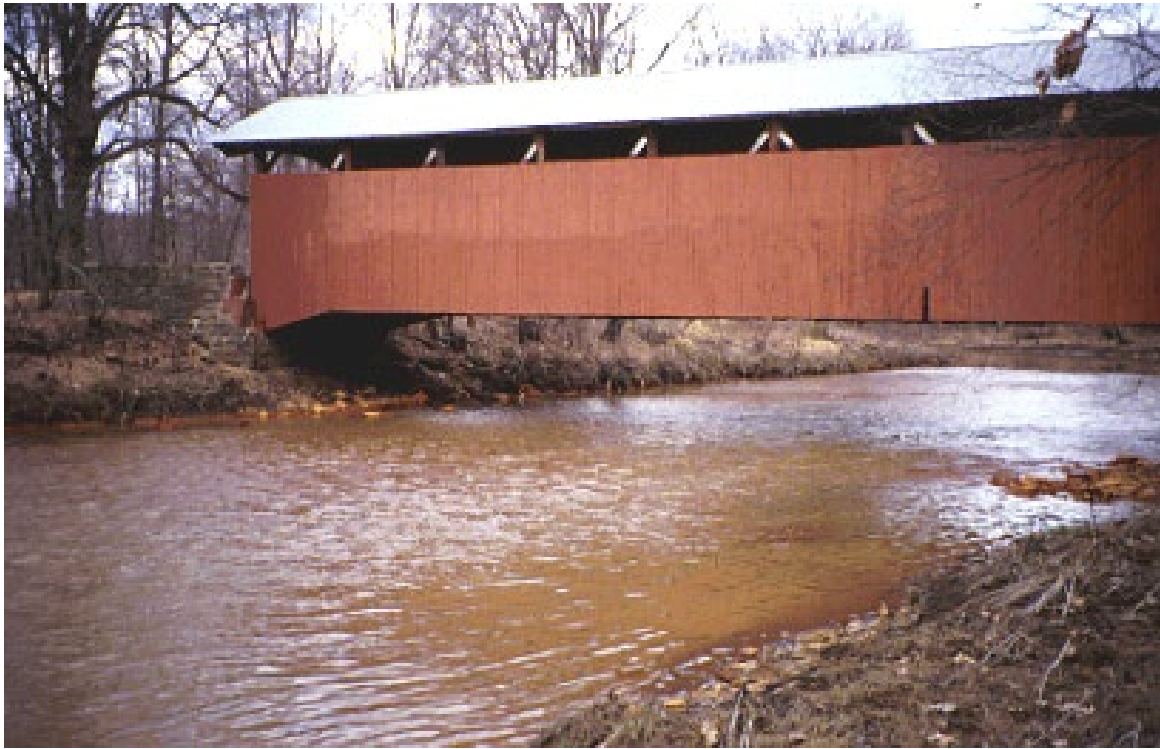
Shamokin Creek 10 miles downstream of the last mine discharge. Color changes often from clear to red depending on rainfall in particular parts of the watershed. The pH ranges from 4 to 6.

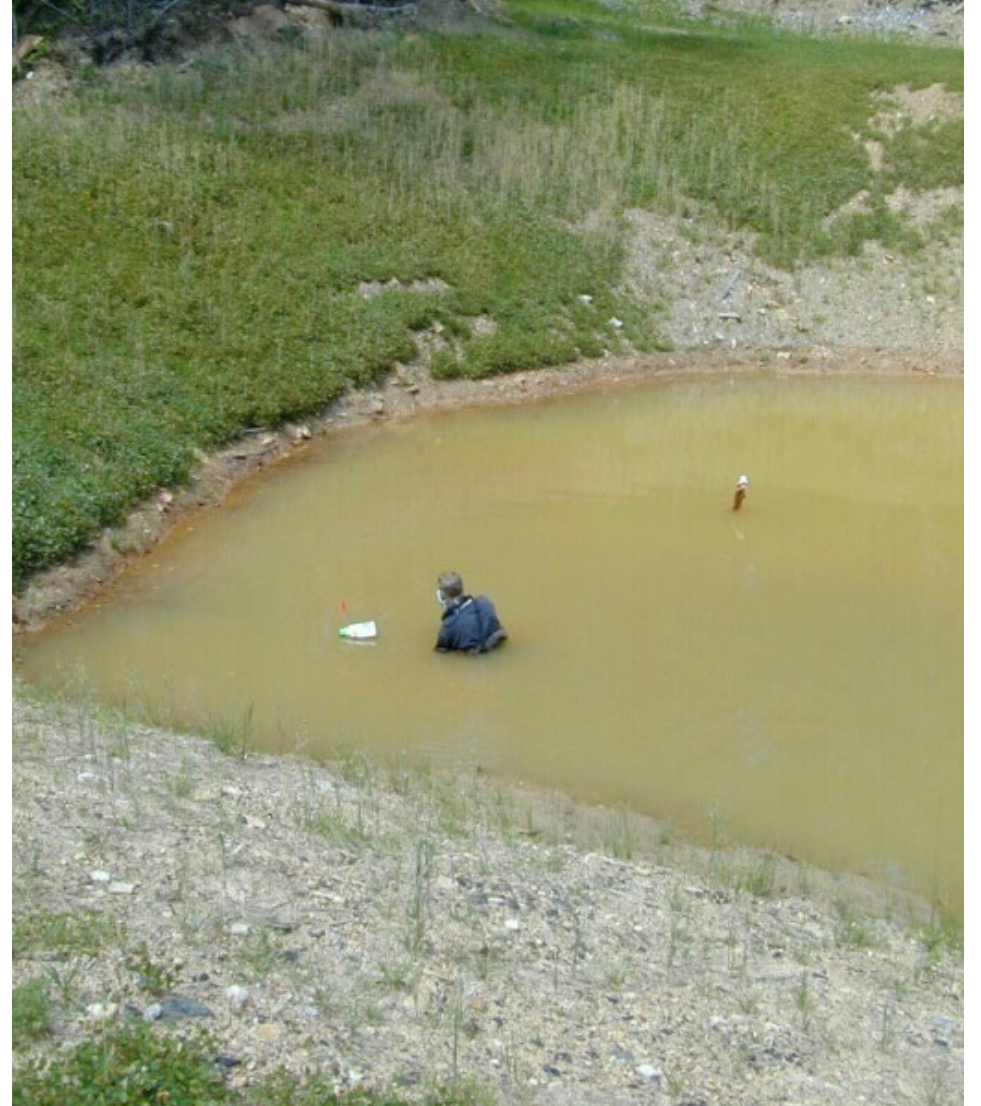
Site 42 treatment system Vertical flow wetland  
Now that's dedication to research!
