Quaker Run and Buck Run Watershed Assessment and Restoration Plan

Aaron S. Clauser, PhD, CPESC
Clauser Environmental, LLC
1915 Leiby Lane
Kutztown, PA 19530
aclauser@verizon.net

Shamokin Creek Restoration
Alliance
PO Box 263
Mt. Carmel, PA 17851
570-286-7114

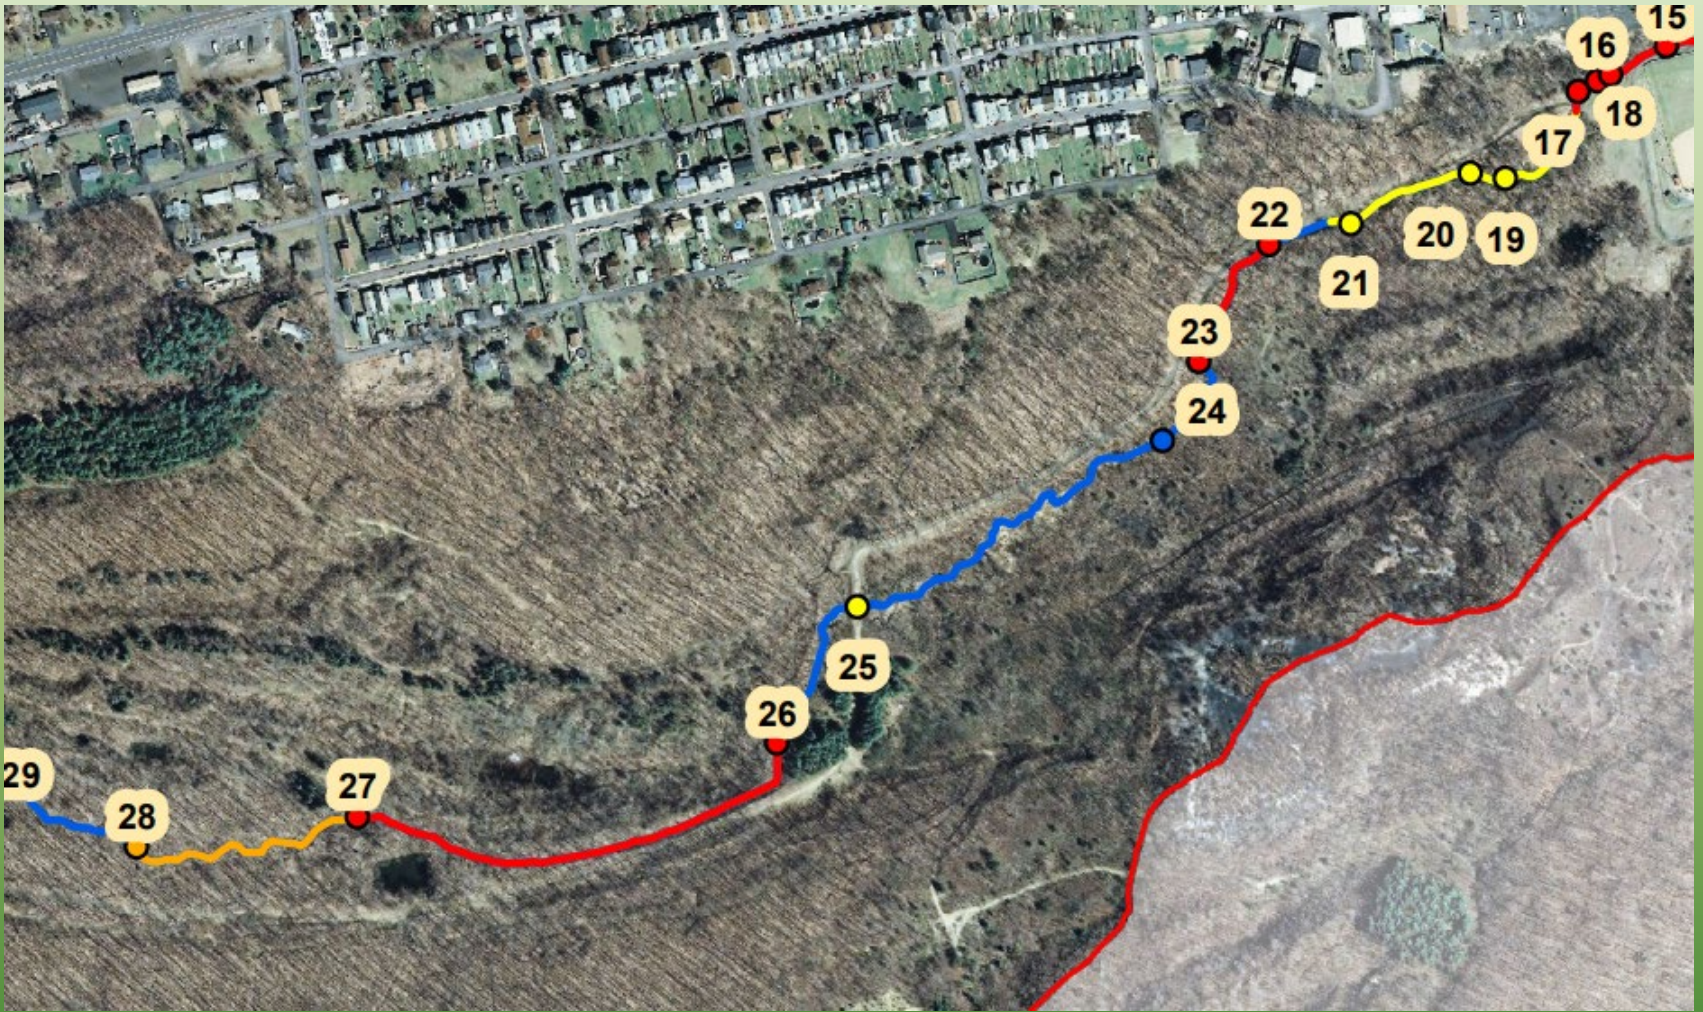
Point #	Description	Action Item	Key Partners	Priority	Comments
24	At this point, multiple braided channels converge into a single thread channel that contains water. The multiple braided channels are in an area of substantial deposition from the upstream eroding streambanks. The channel is stable downstream of this point.				
25	Upstream of this point, the stream channel is connected to the floodplain, is stable, and contains flowing water. A culvert at this point carries the stream under an existing dirt road.	Stabilize the road with gravel or driving surface aggregate	Landowner	Low	
26	The stream is diverted to the south of a strip mine pit that is located in the central part of the valley floor in this location.	Mine reclamation	SCRA, BAMR, Landowner	High	
27	The streambanks are eroded and 2-3' high downstream and for approximately 100' upstream of this point. The upstream channel is diverted around strip mine pits and is not located in the historic location on the valley floor. Clay is present on the bottom of the channel. Flowing water was present on the day of the streamwalk. No fish were observed in this area.	Mine reclamation, streambank stabilization	SCRA, BAMR, NCCD, Municipality, Landowner	High

28	The streambanks upstream of this point are 2-3' high and actively eroding. Downstream of this point, the streambanks are stable and connected to the floodplain.	Streambank stabilization	SCRA, BAMR, NCCD, Municipality, Landowner	Medium	
29	Upstream end of large created wetlands				
30	At this point, an unstable ford crosses over the downstream portion of the constructed wetlands. Downstream of the ford, the wetland drains back into a stream channel.	Stabilize ford crossing	SCRA, NCCD, Landowner	Low	
31	The access road to Reinhart Foodservice crosses over the stream in this location.				The upstream restoration area is providing excellent habitat and improving water quality.
32	The outfall from the road crossing has created a scour hole that contains sunfish and other fish. The downstream corridor was previously restored and planted with riparian vegetation.

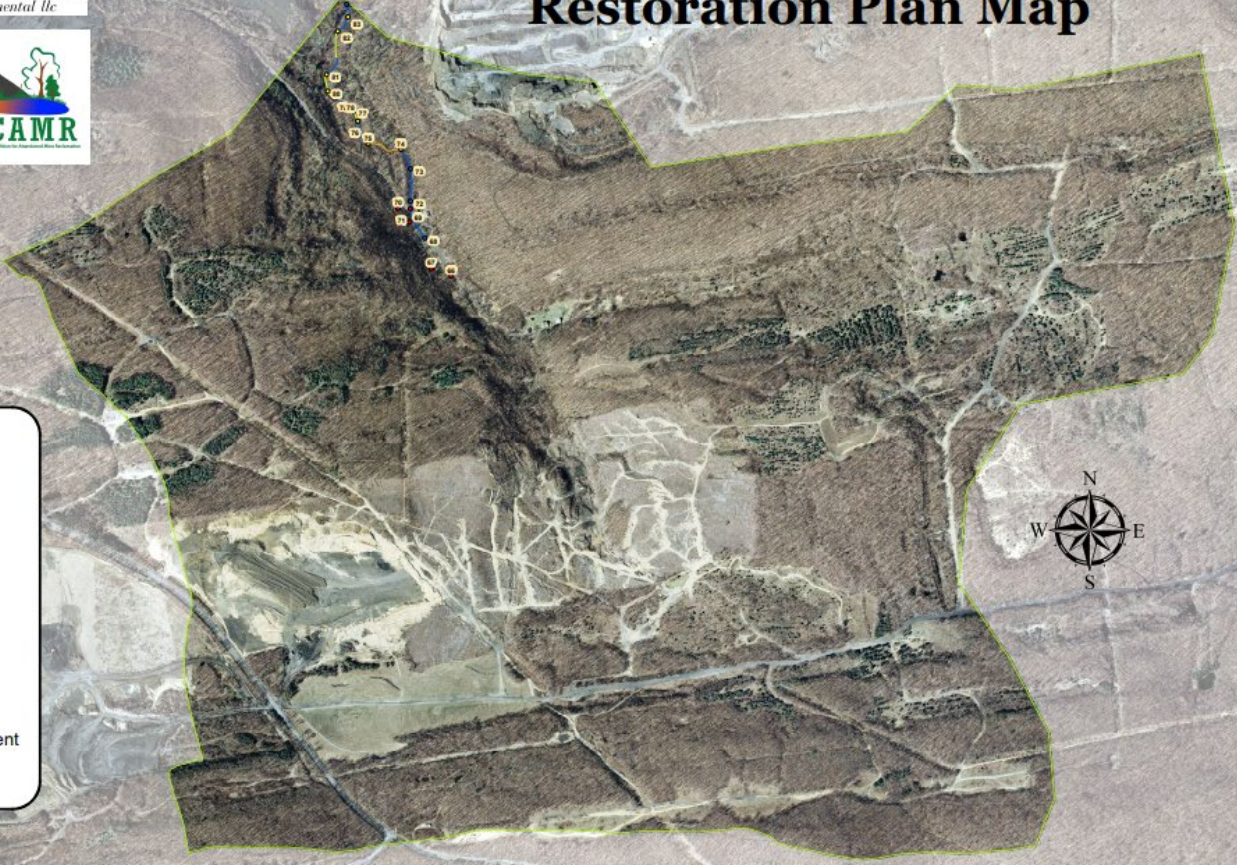
Impacted Stream Segment #67-71:

- The Big Mountain Discharge is the principal contributor to Buck Run flow
- Heavy contamination of metals
- Average pH of 4.40

- Remining, reclamation and limiting flow to the mine pool
- Treatment of the mine discharge
